# Kindergarten Vejtoften, Høje-Taastrup, Denmark Vejtoften 1, 2630 Taastrup

# **IEA SHC Task 47** Renovation of Non-Residential Buildings towards Sustainable Standards

Brochure authors: Jørgen Rose and Kirsten Engelund Thomsen Danish Building Research Institute, AAU Contact: jro@sbi.aau.dk

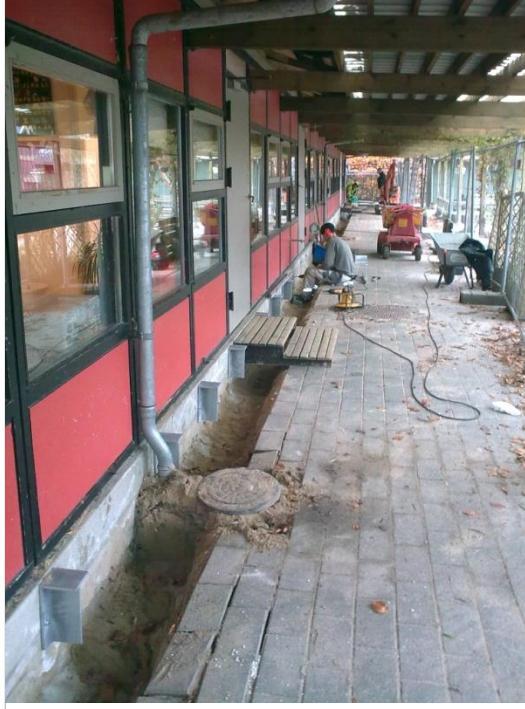
Above: Façade before renovation Below: Existing insulation and windows

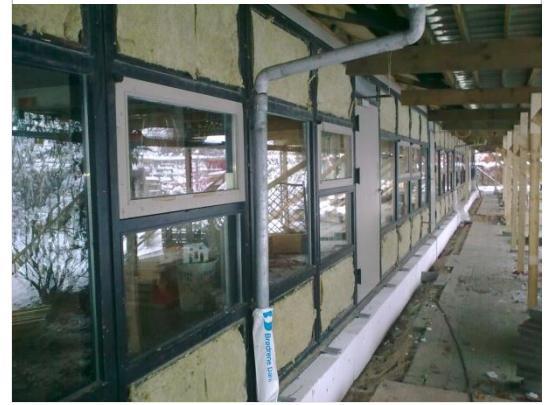
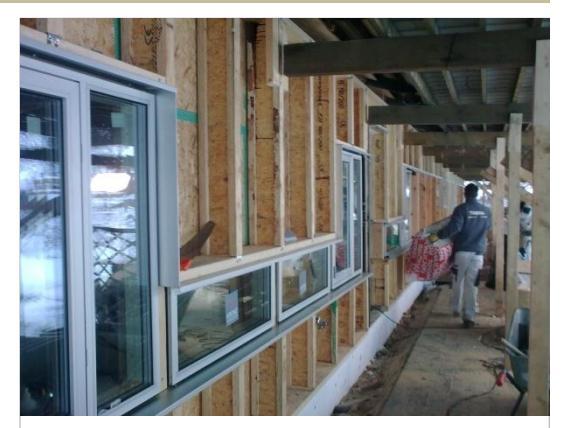
Above: Old insulation has been removed and new windows have been installed Below: New insulation has been added

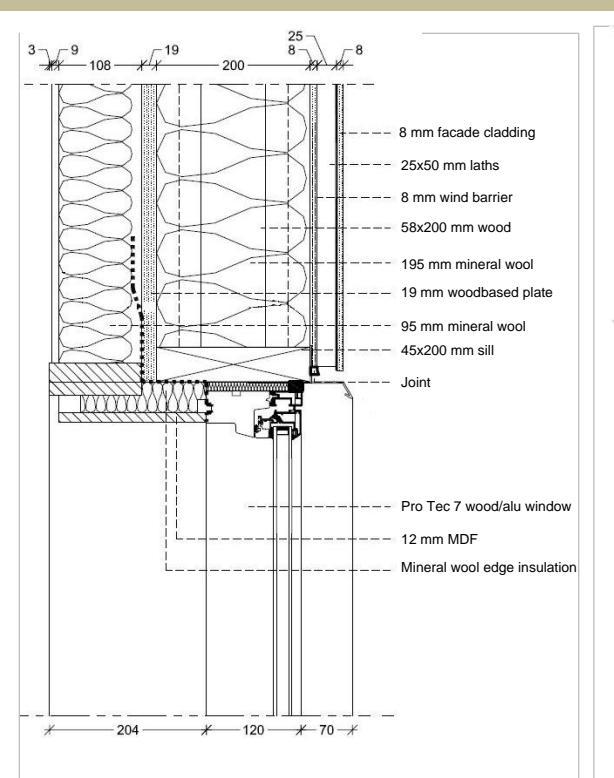
Cross section window/wall joint. The existing insulation of 95 mm was replaced and a new layer of 195 mm insulation was added to the exterior wall. The window was moved out in the construction. The original thermal bridges in the wall and the thermal bridge at the joint are reduced significantly.

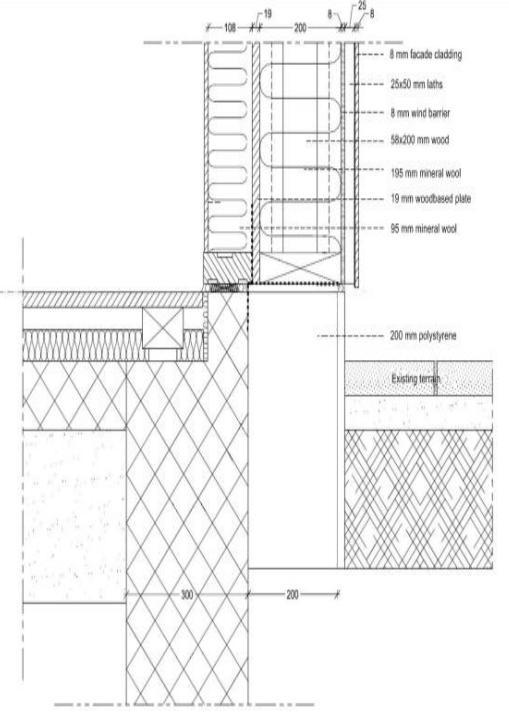
Cross section floor slab/wall. 200 mm x 400 mm insulation was added to the base of the building to reduce thermal bridge effects. In addition to reducing the heat loss this has also raised the temperature of the floor and thereby improved the indoor climate. Now the entire floor area is useable for the occupants.

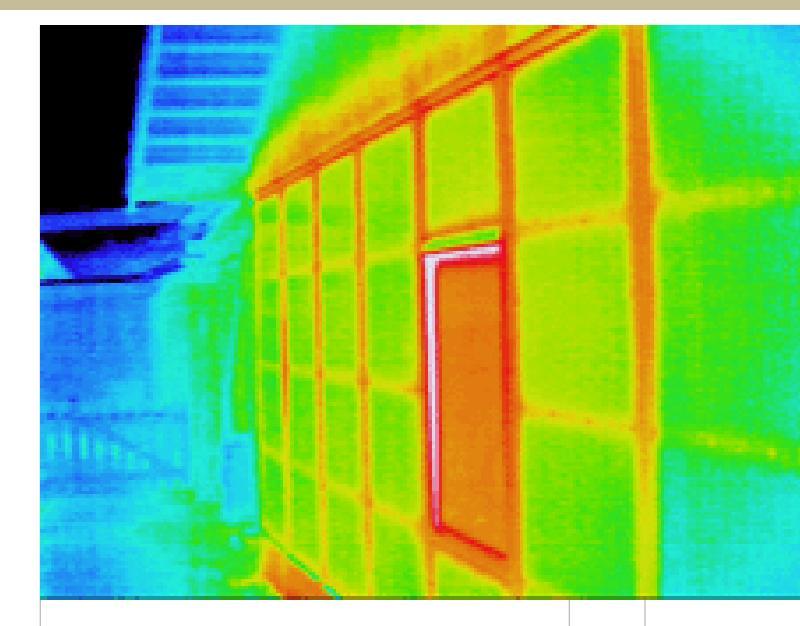
Left: Thermography before renovation. Notice how the beams in the existing wall and the frame of the window create large thermal bridges. Also the window itself is showing a significant heat loss.

Right: Thermography after renovation. The thermal bridges have disappeared almost completely, and it is clear that the two layers of insulation are efficient in reducing the heat transmission through the thermal envelope. The heat loss through the window also has clearly decreased.

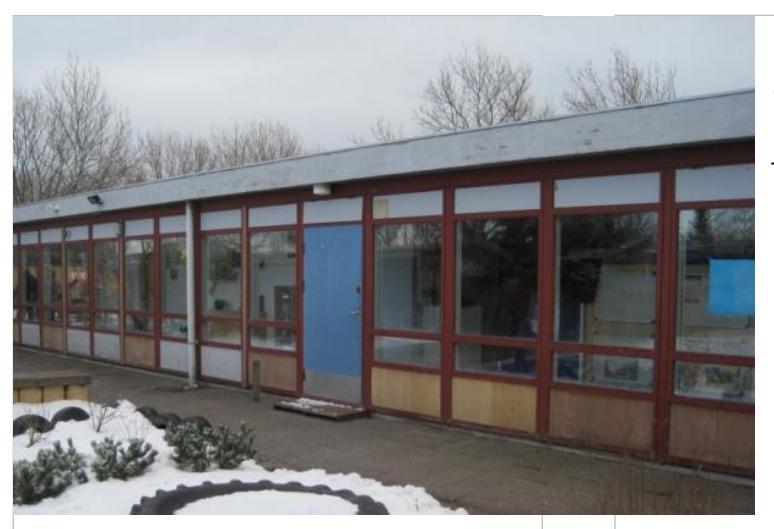
Right: Facade facing the playground after renovation. The new facade requires little/no maintenance. Left: Facade facing the playground before renovation. The painted facade required regular maintenance.
