Office and workshop building, Fraunhofer ISE Campus, Freiburg, Germany

IEA SHC Task 47

Renovation of Non-Residential Buildings towards Sustainable Standards

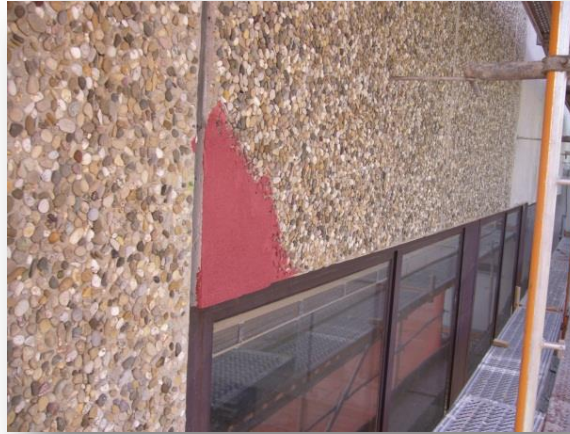
Façade detail - Before retrofit.

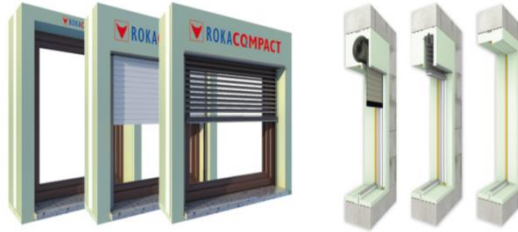
Above: Prefab window frame from market
Below: Adapted prefab window frames with air inlets-/outlets on top

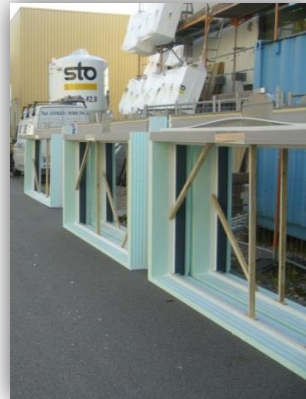
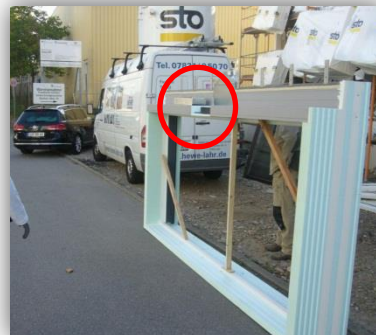
Easy mounting of the prefab frames and window

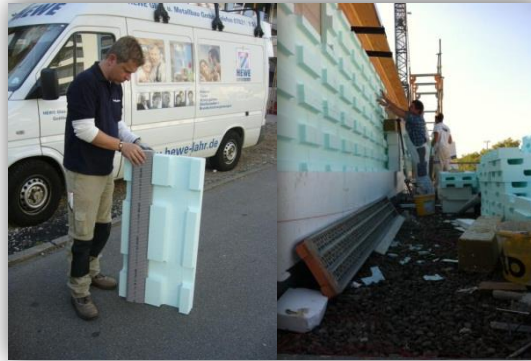
First 100 mm layer insulation with air ducts

The wall insulation was mounted as a classic external wall insulation system with adhesive and mechanical fixation. In areas with ventilation system 2 layers of insulation have been mounted: first layer with air ducts - then second layer covering the ducts.

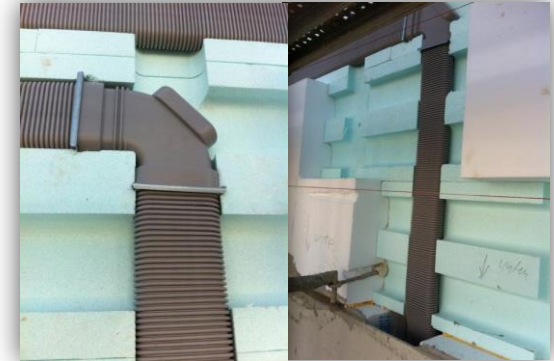
Second 140mm layer insulation covering airducts

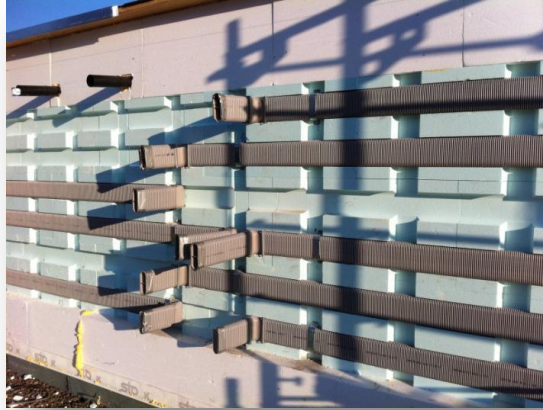
Above: Ventilation ducts refab window frame with air inlets/outlets on top

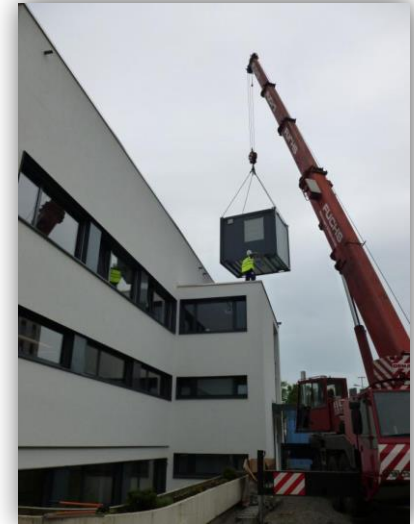
Above: container with air handling unit

The new ventilation system was installed on the exterior wall. Air handling unit was installed in a container as a test unit to change, adapt and test several air handling units.

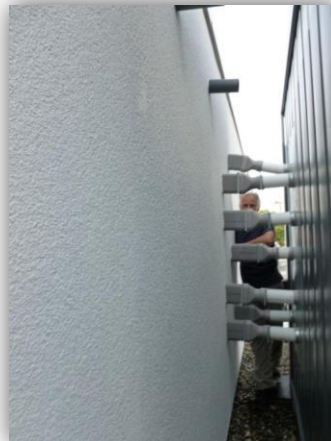
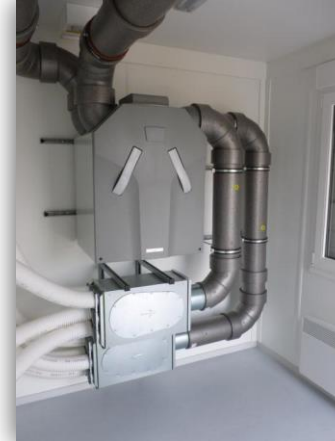
Below: duct connection to the air handling unit in container

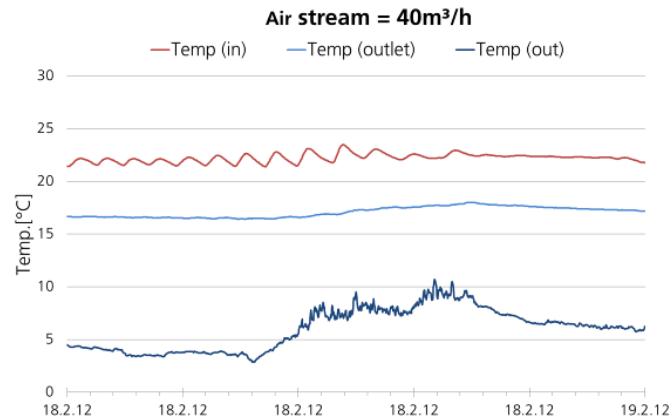
Above: Air Inlet/Outlet

Below: Performance of the façade integrated ventilation system

The comfort criteria are fulfilled and the performance of the façade integrated ventilation system - a demonstrator - is better as expected and will be monitored during operation.
