TASK 27

Performance of Solar Facade Components

Final Report

PROJECT B3: Durability and reliability assessment of static solar materials

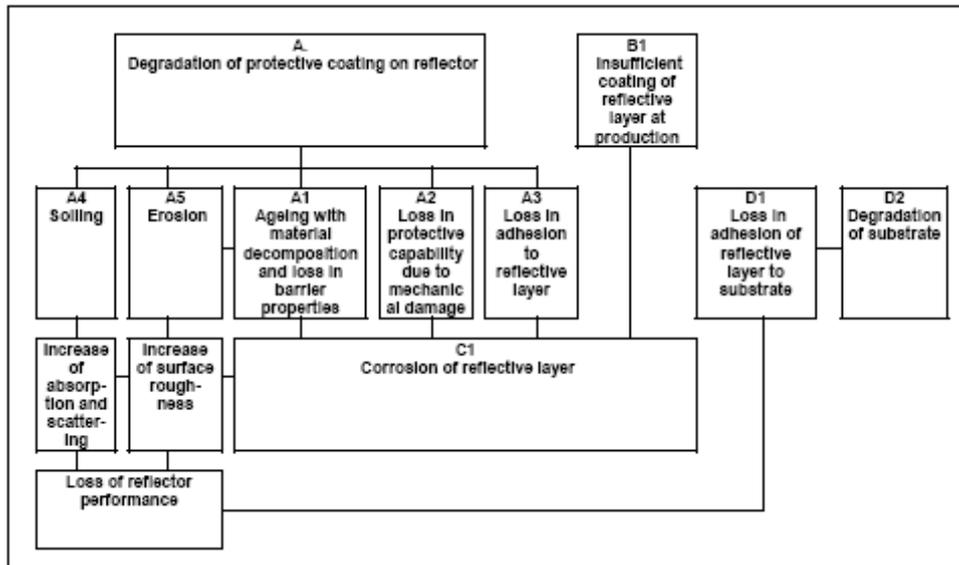
Figure 1: Representation of failure modes and associated degradation mechanisms for booster reflectors

In Figure 1 and Figure 2 examples on how the different failure modes and associated degradation mechanisms can be represented for booster reflectors and antireflective glazing materials, are shown.

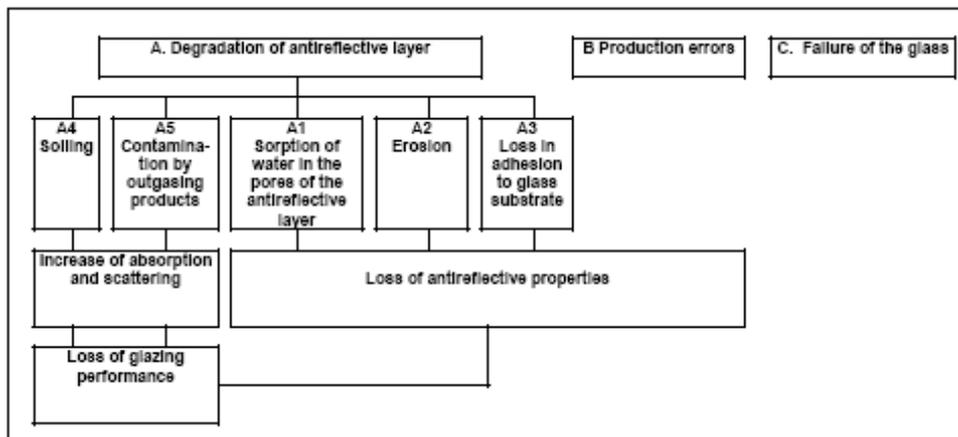
Figure 2: Representation of failure modes and associated degradation mechanisms for antireflective glazing

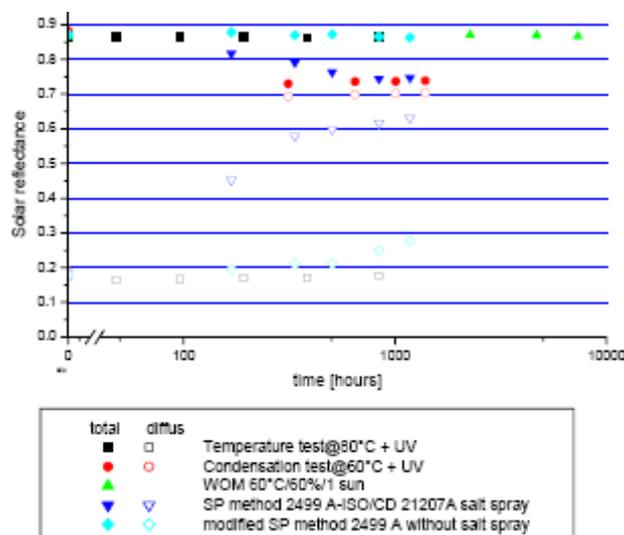
Figure 3: Results from screening tests on pure Aluminium

In Figure 3 the results from a series of screening tests on pure aluminium, used as reference reflector material, are shown as an example of result. Degradation in optical performance is observed mainly, as expected, in the corrosion tests. In Figure 4 the result from the testing of a number of antireflective glazing materials at 80 °C and 95 %RH is given. The cause of degradation in optical performance is in this case not understood and the degradation therefore needs to further analysed. To identify degradation mechanisms for the tested materials various analytical techniques are presently employed.

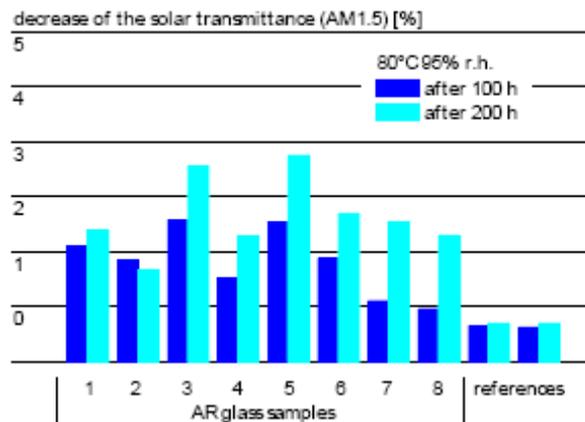
Figure 4: Result of the most significant screening test on antireflective glazing materials involving exposure at 80°C and 95 %RH

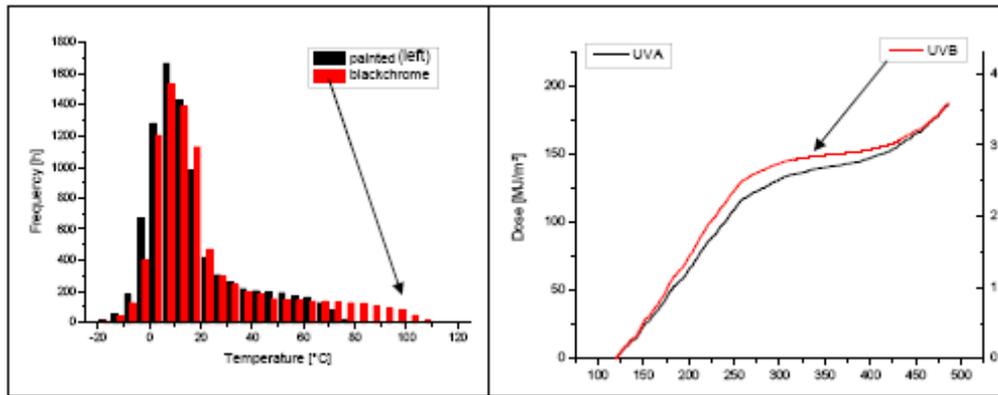
Figure 5: Microclimatic data measured during outdoor exposure of solar façade absorbers at ISE. Left diagram: Surface temperature frequency histograms for a black painted and a black chrome absorber; Right diagram: UVA and UVB light doses versus exposure time.

For measurement of microclimatic variables relevant in the assessment of durability of the static solar materials studied in Task 27, various kinds of climatic data during outdoor exposure at different test sites are monitored such as global solar irradiation, UV-radiation, surface temperatures, air humidity, precipitation, time of wetness, wind conditions, and atmospheric corrosivity. Such data will be used to predict expected deterioration in performance over time by making use of degradation models developed from results of accelerated tests. Some results from the measurement of microclimatic data are shown in Table 6 and Figure 5.

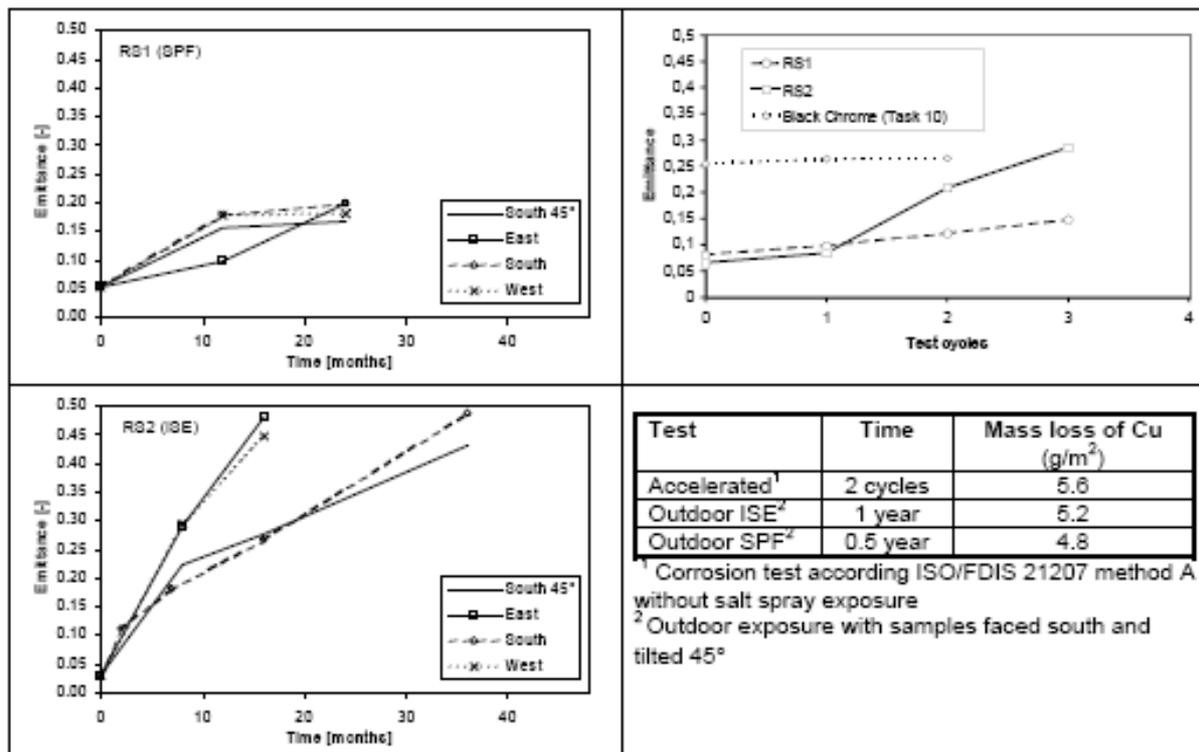
Figure 6: Change in thermal emittance observed for some reference solar façade absorber materials during outdoor testing and during accelerated corrosion testing. The corrosivity dose in terms of metallic mass loss of copper at an exposure time is also given for the different tests to illustrate that outdoor performance of those absorbers can be predicted by making use of the equivalent corrosivity dose approach.

In Figure 6 is illustrated how the principle of equivalent corrosivity dose in accelerated corrosion testing can nicely be adopted in the prediction of the long-term outdoor performance of some solar façade absorbers. A prerequisite for this is that the accelerated corrosion test correctly simulates the predominating corrosion mechanism occurring under normal outdoor conditions.

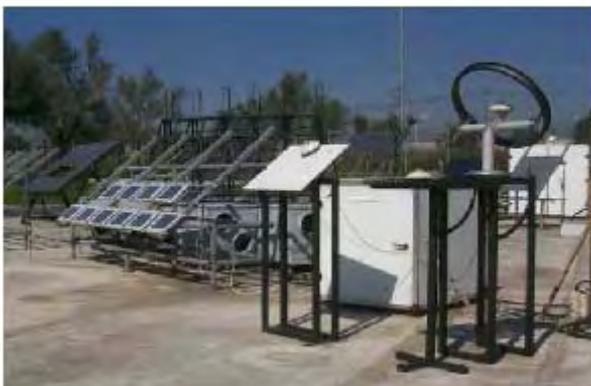
Figure 7: View of the outdoor exposure site with facilities for monitoring of climatic data at INETI in Lisbon

In the case studies of Task 27 outdoor tests at different test sites are performed for measurement of microclimatic variables and for validating predicted loss in outdoor performance from accelerated test results. Tests are performed by CSTB in Grenoble (France), ENEA in Rome (Italy), INETI in Lisbon (Portugal), ISE in Freiburg (Germany), NREL in Colorado/ Florida/Arizona (USA), SP in Boras (Sweden), SPF-HSR in Rapperswil (Switzerland) and Vattenfall in Älvkarleby (Sweden). In Figure 7 a view of the test site at INETI in Lisbon is shown.

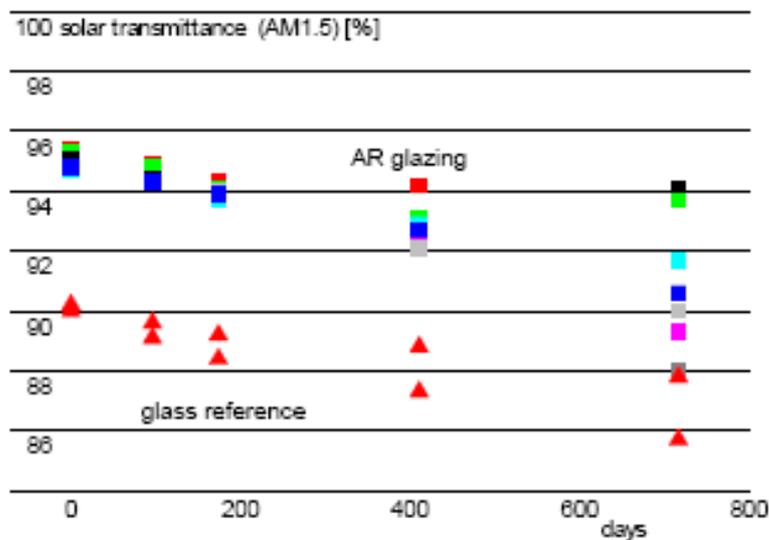
Figure 7: Results from outdoor exposure of antireflective glazing materials performed at SPF-HSR Rapperswil, Switzerland. The decrease in the solar transmittance with time is due to soiling effects, which vary very much with exposure site.

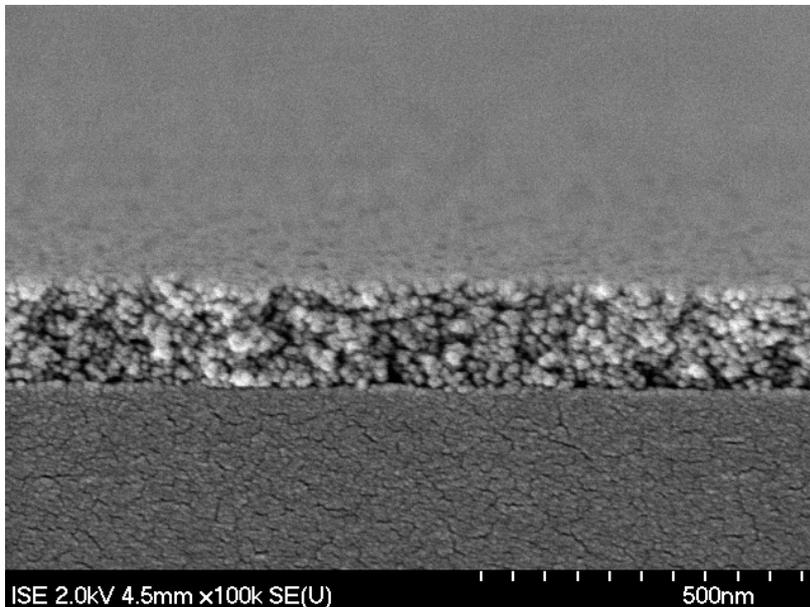
Fig. 1: SEM picture of a cross section of a porous sol-gel coating on glass.

applied in thicknesses from 120 – 140nm and contain almost only SiO₂ and air. The solar transmittance (AM1.5) of a glass pane AR treated on both surfaces is typically increased by around 5% under near-normal incidence.

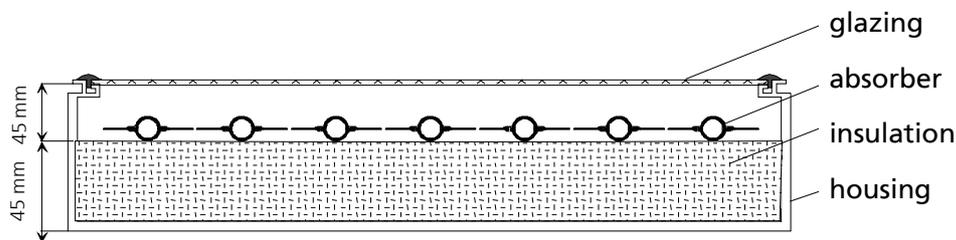
Fig. 2: Sketch of a solar thermal collector

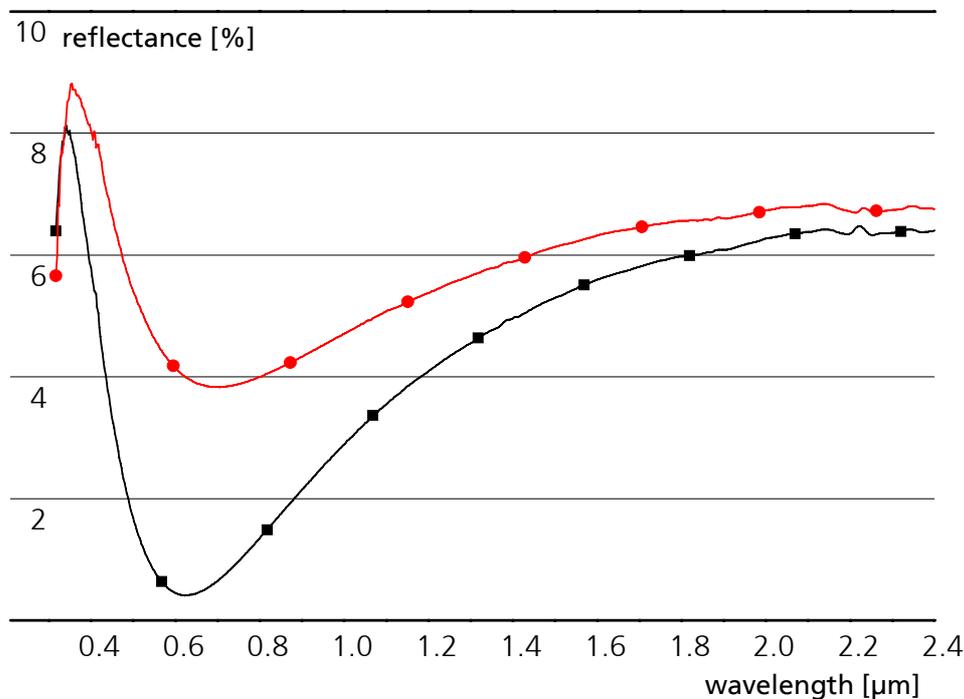
Fig. 3: Reflectance spectrum of an AR glazing before (squares) and after (dots) 170°C absorber temperature for 24 h on a small test solar collector equipped with a thermal insulation containing a high amount of phenolic resin as binder.

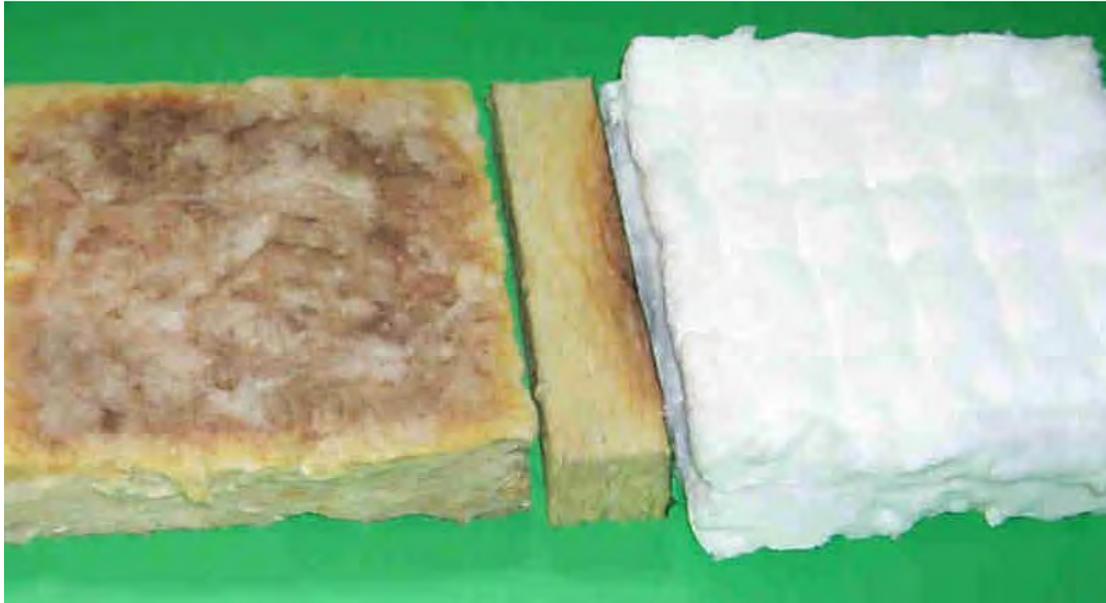
Fig. 4: Photo of different insulation materials based on mineral wool after treatment in a small test solar collector at stagnation temperatures for 24 hours (left and middle: top view and cross section of a mineral wool containing phenolic resin; right: binder-free wool)

This is possible due to the high temperature gradient within the thermal insulation. This temperature gradient can be made visible by the brownish colour of degraded phenolic resin which is shown in Fig. 4. So-called binder-free mineral wool is not in general better than mineral wool containing binders. Some of the binder-free mineral wool which we tested did not contain phenolic resin but contained large amounts of other organic materials. As a result, the materials used in combination with porous AR layers should be selected carefully.

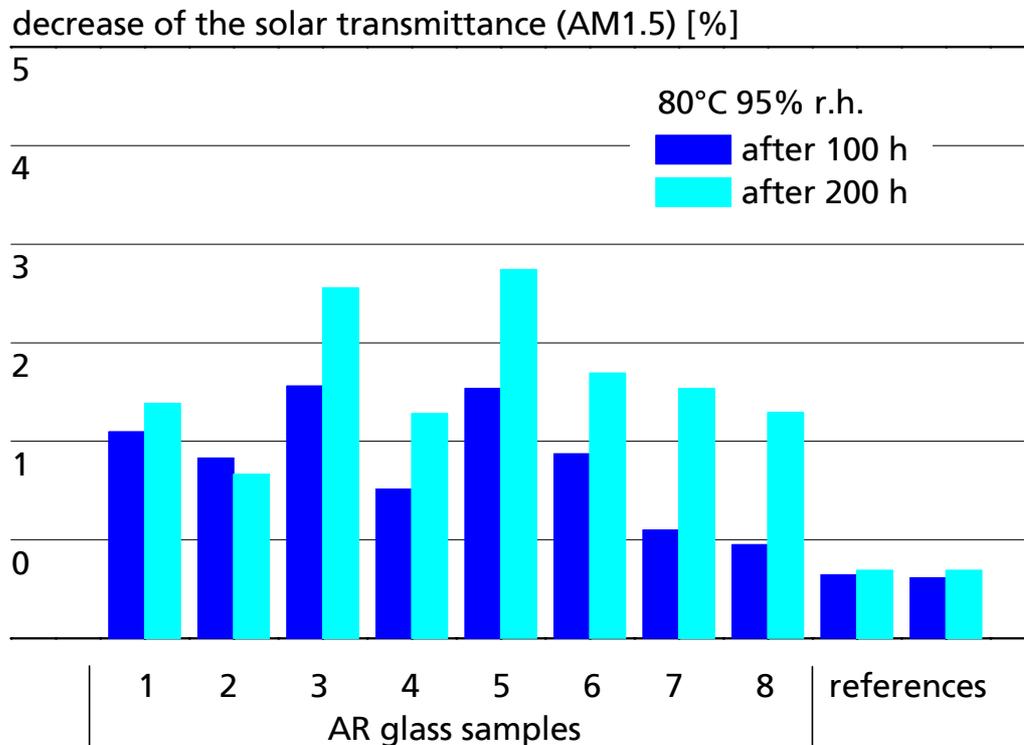
Fig. 5: Decrease of the solar transmittance of the samples from the initial values after testing 100h and 200 h at 80°C/ 95% r.h. The variation of the reference values is probably due to measurement errors

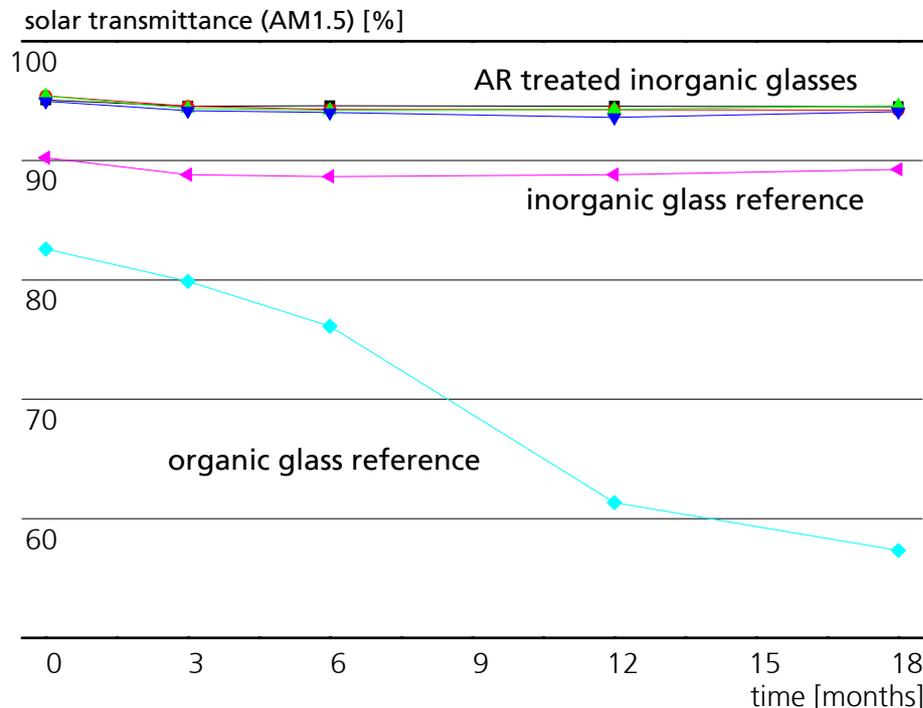
Fig. 7: Measured values of the solar transmittance (AM1.5) for the samples exposed at Freiburg, Germany, during the first 18 months.

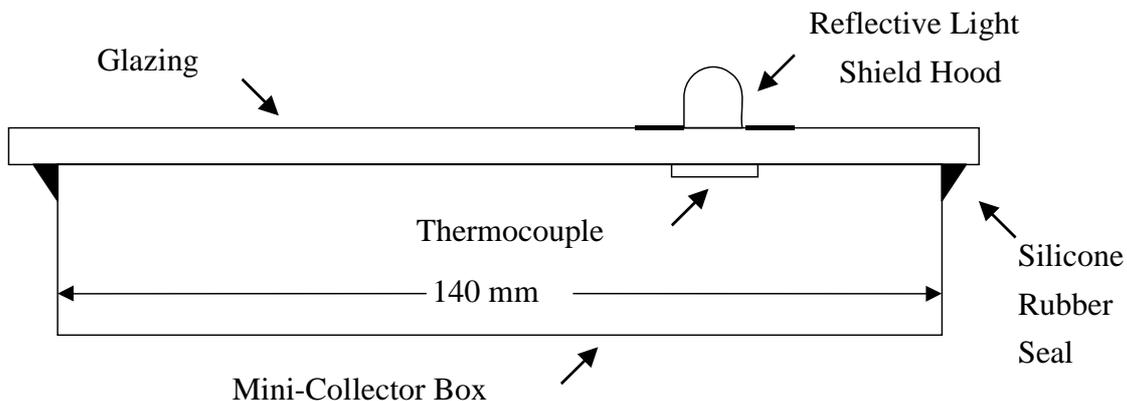
Figure 1: "Mini-collectors" used for outdoor exposure of transparent cover materials

The materials tested are for the intended use in solar thermal flat plate collectors. Thus, the samples for outdoor exposure were attached to mini-collector boxes, as illustrated in Figure 1. To simulate the elevated temperature collector covers are exposed to, the "mini-collectors" are made of solar selective coated stainless steel. A thermocouple is affixed to the glazing material to monitor sample temperature, and a reflective light shield hood is used to prevent direct heating of the thermocouple.

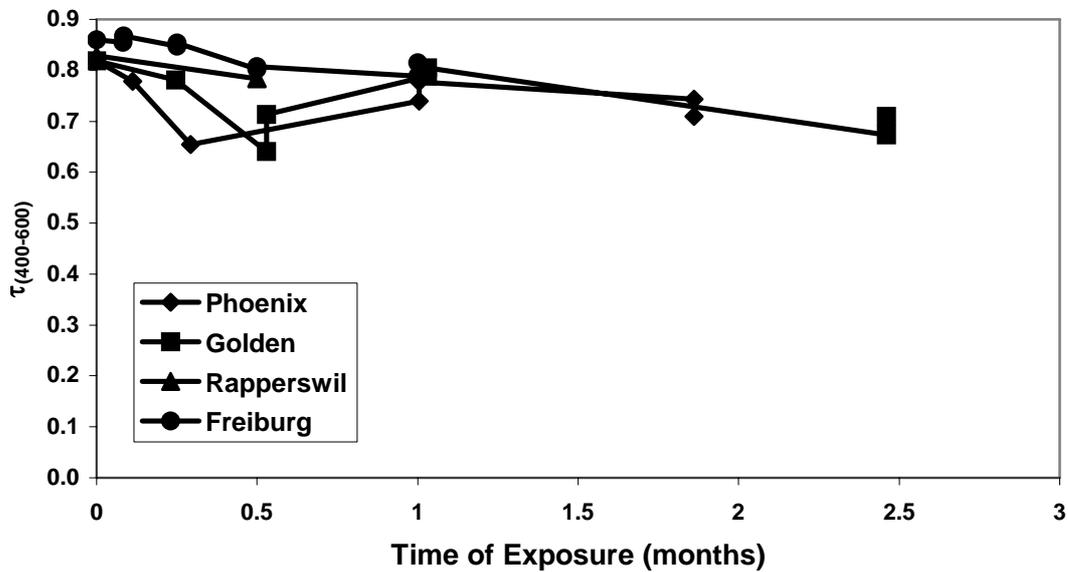
Figure 2: Outdoor exposure test results for APEC 9353 PV

Representative τ (400-600) data are plotted in Figures 2 and 3 for APEC 9353 PC and Duraglas PVC, respectively. Figure 2 shows a loss in τ (400-600) of about 5% per year for samples of APEC 9353 exposed outdoors in Europe and the US. Duroglas, a PVC glazing material, degrades very rapidly when exposed to UV light. Figure 3 presents outdoor test results for Duroglas exposed in the United States and Europe. Samples of Duroglas exhibited between 25-40% loss in τ (400-600) after only one year exposure, depending upon the outdoor site.

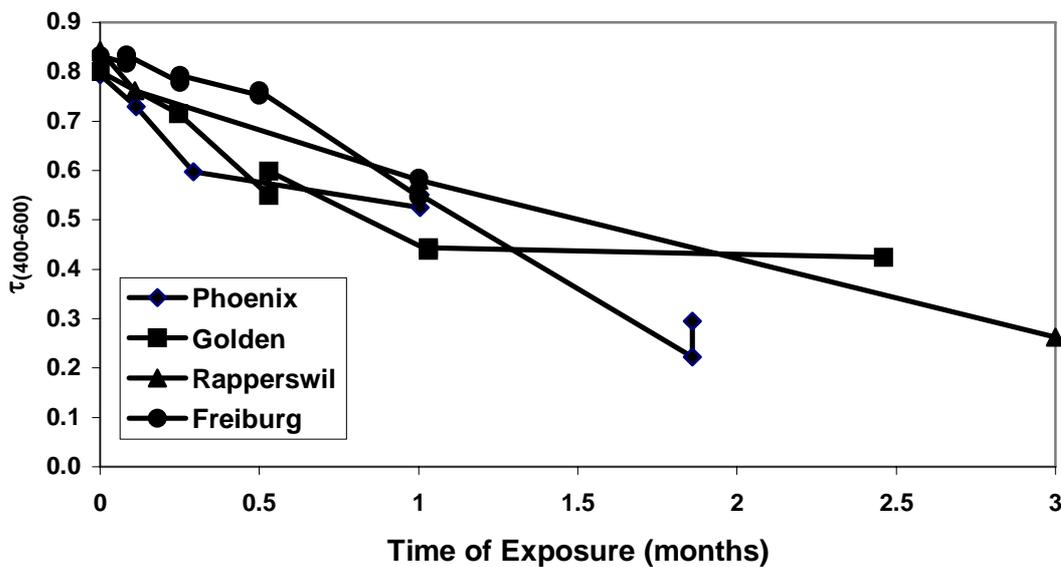
Figure 3: Outdoor exposure test results for Duroglas PVC

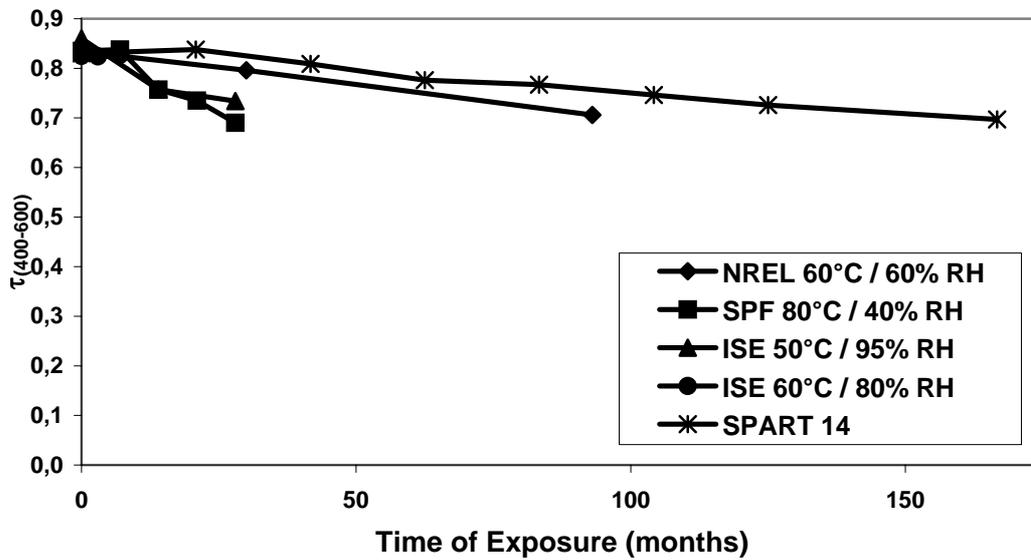
Figure 4: Accelerated exposure test results for APEC 9353 PC

The values obtained for τ (400-600) are plotted in Figures 4 and 5 for APEC 9353, and Duroglas after the different types of exposure. Figure 4 shows that results for APEC 9353 exposed in the SPART 14 chamber are in good agreement with Ci5000 data. However, exposure of APEC 9353 in the unfiltered metal halide chambers is much more severe than in the Ci5000 and SPART 14. With the unfiltered metal halide light source, a ~15% loss in τ (400-600) occurs after only 25 days, whereas it took roughly 100 days for an equivalent loss to occur in the Ci5000 and SPART 14.

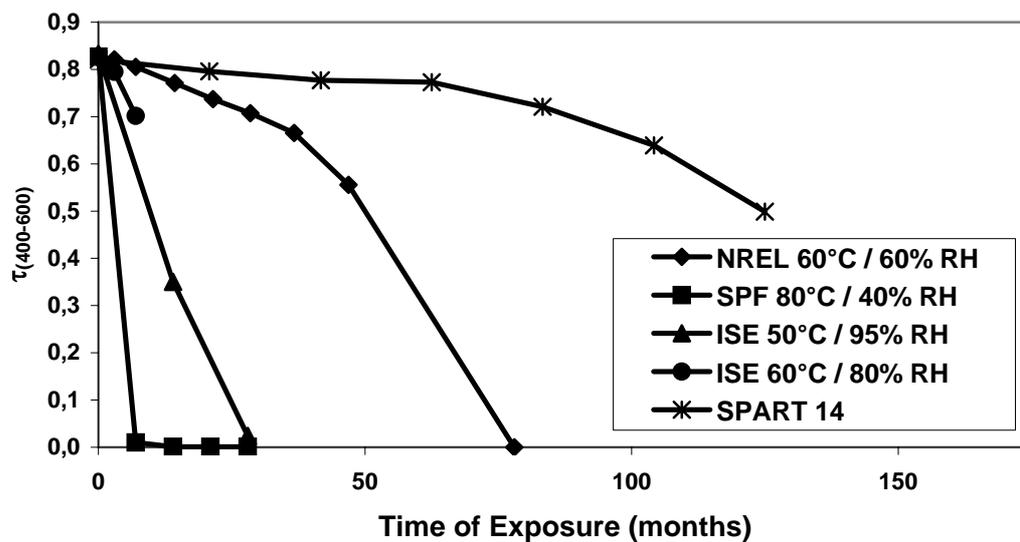
Figure 5: Accelerated exposure test results for Duroglas PVC

Accelerated exposure test results for Duroglas PVC are provided in Figure 5. Exposure of Duroglas in the unfiltered metal halide chambers at a variety of temperature and RH conditions produced rapid degradation. Results for Ci5000 WOM exposures were less severe, although precipitous degradation did occur in fairly short time periods. Duroglas exposed to the SPART 14 chamber conditions results in considerably less degradation than for the unfiltered metal halide and Ci5000 chamber exposures.

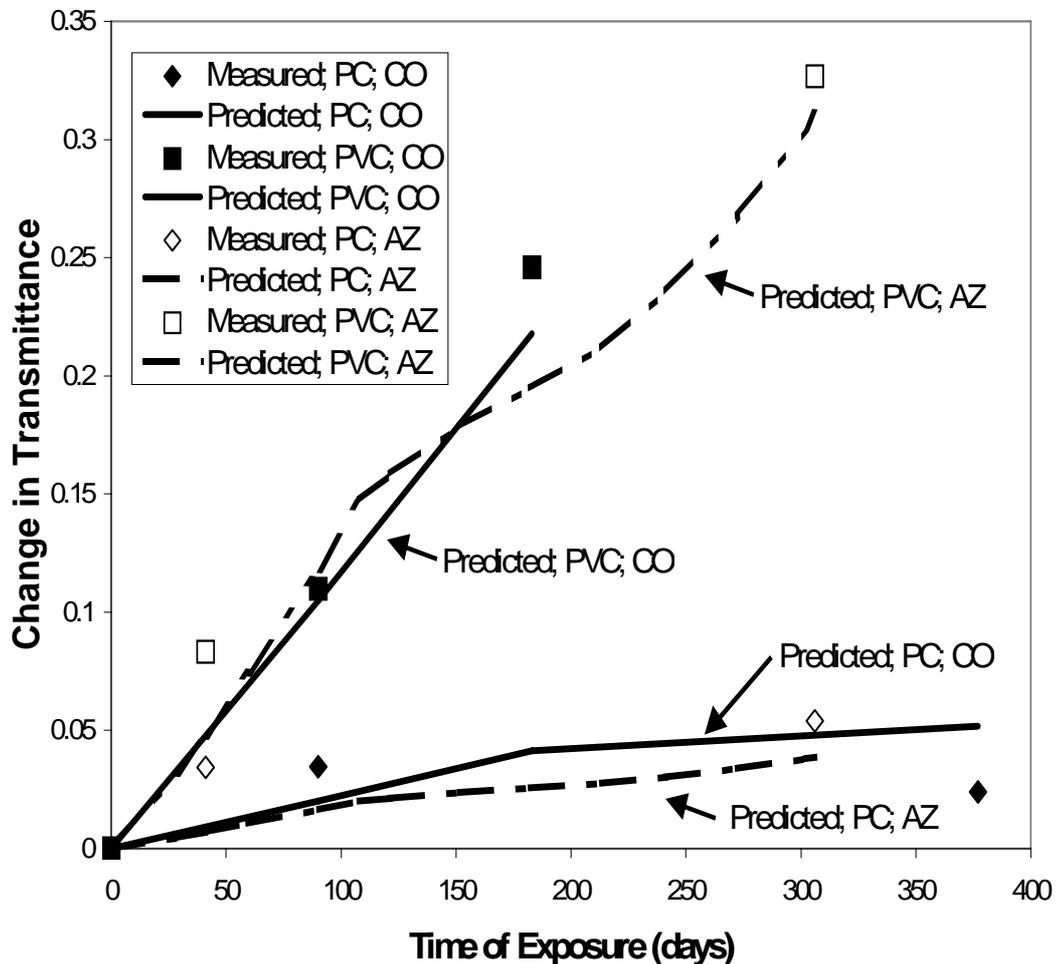
Figure 6: Comparison of the actual and predicted changes (loss) in hemispherical transmittance between 400-500 nm of PVC and PC for exposures of up to 380 days at Golden, CO and Phoenix, AZ.

Using the values of the coefficients E and p from Table 1 and the time-monitored values of sample temperature and UV irradiance, the loss in performance was predicted for both the PVC and the UV-stabilized PC as exposed outdoors in Golden, CO, and Phoenix, AZ. Predicted values were then compared with actual measured data for these materials exposed at these sites. The results are shown in Figure 6. The time-dependent changes in the weathering variables result in the irregular shapes of the predicted curves. Excellent agreement is evident between the measured and predicted data. Thus, the phenomenological approach to data analysis is validated i.e., obtaining model coefficients from accelerated test results and then using these coefficients to predict time-variable in-service degradation.

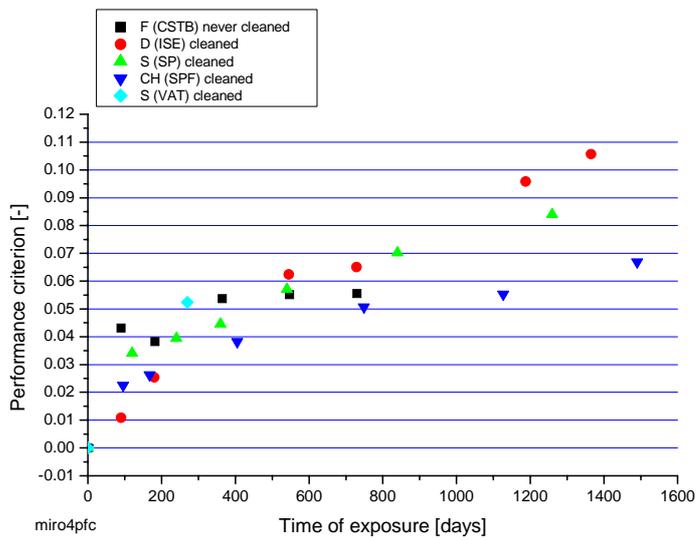
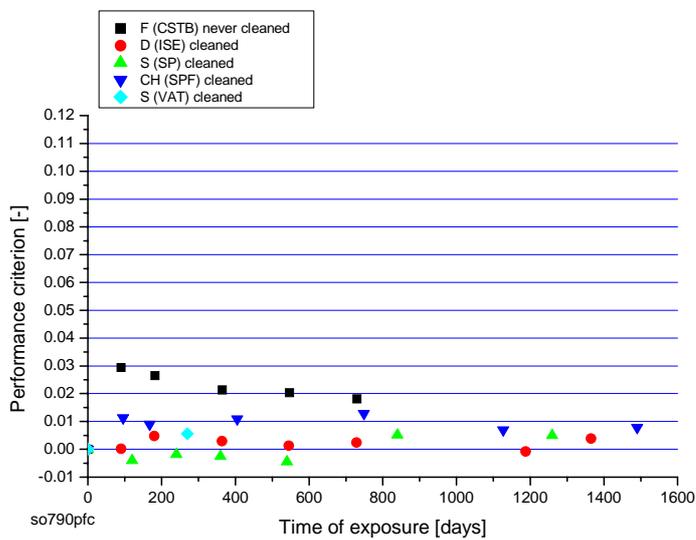
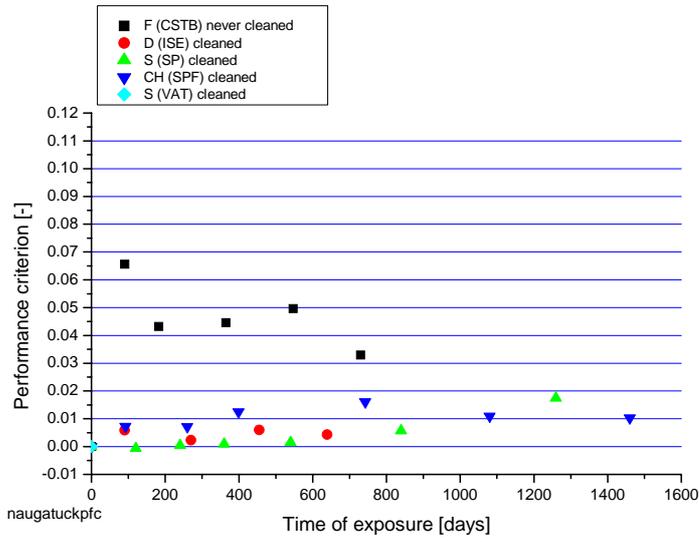
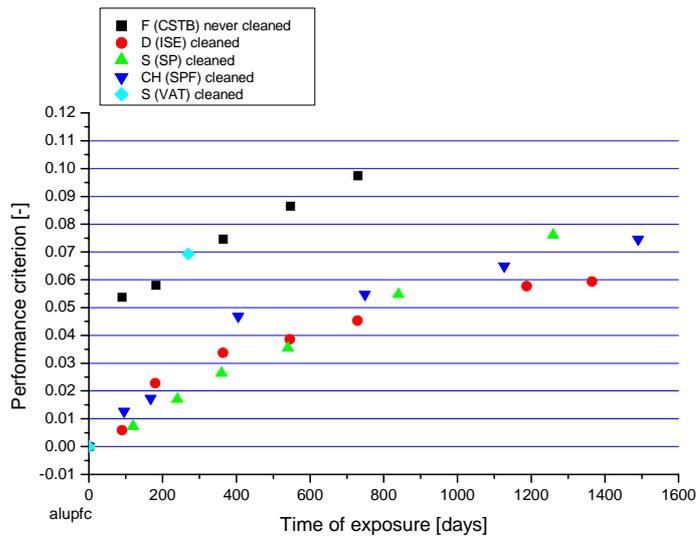
Performance criterion vs. exposure time

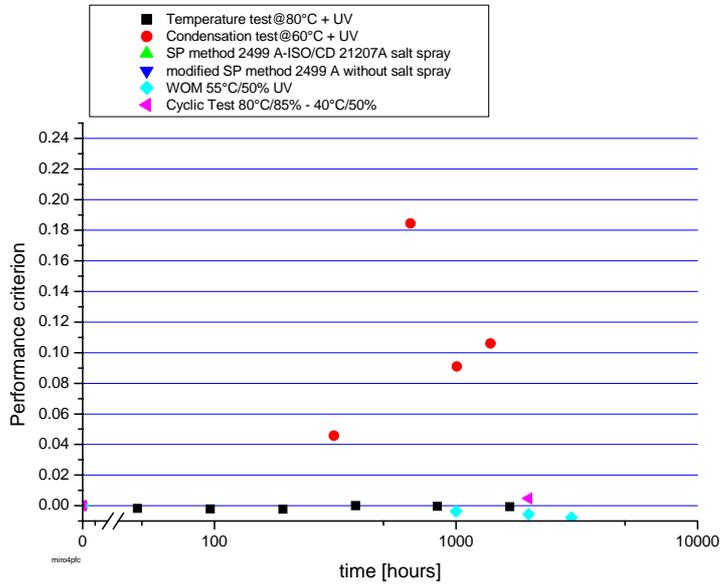
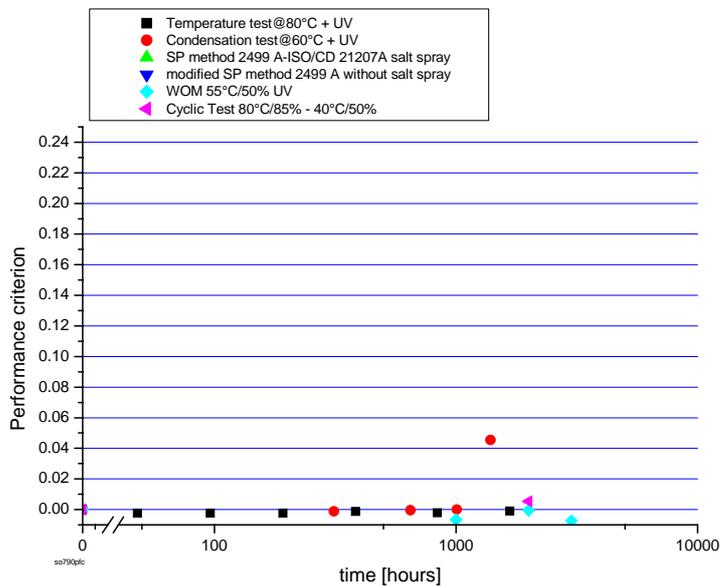
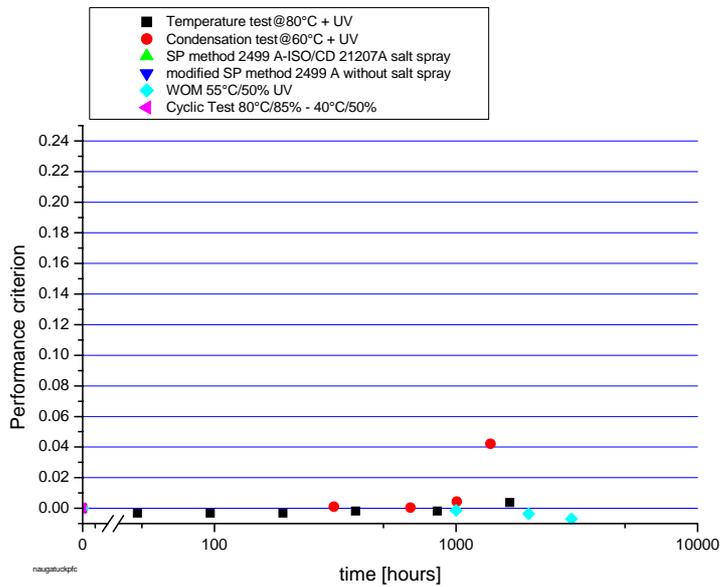
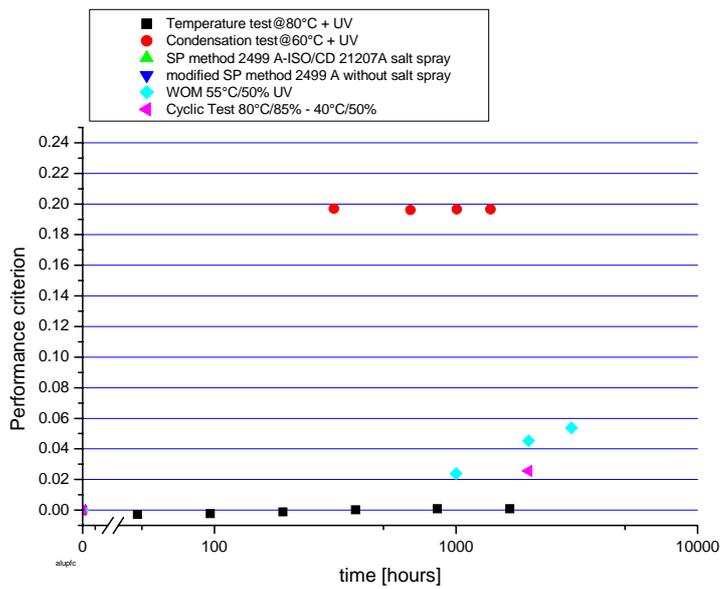
The same samples, also performance criterion, but results from indoor tests

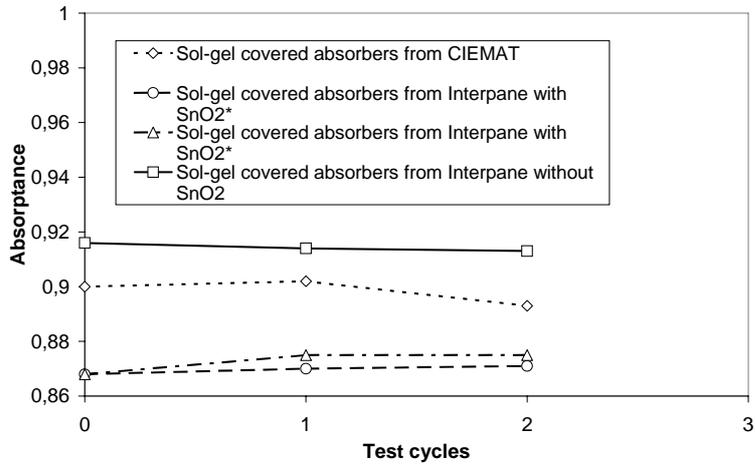
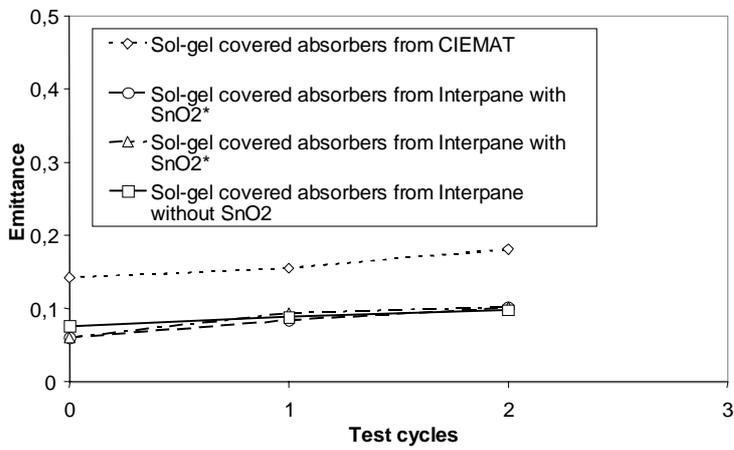
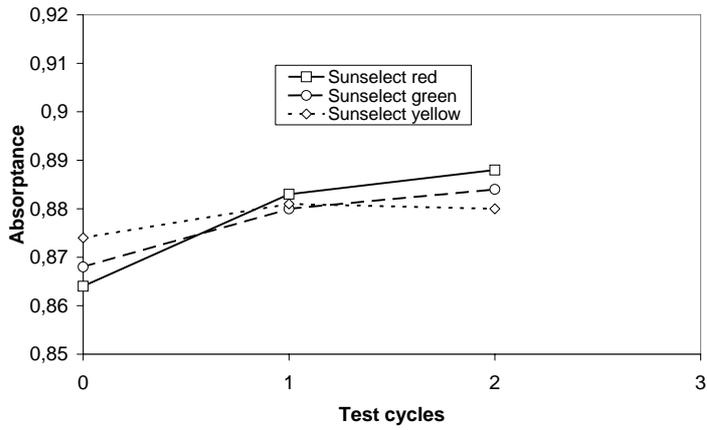
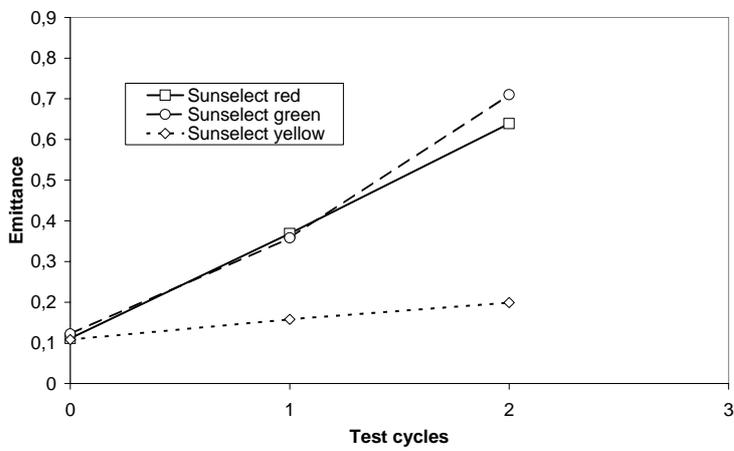
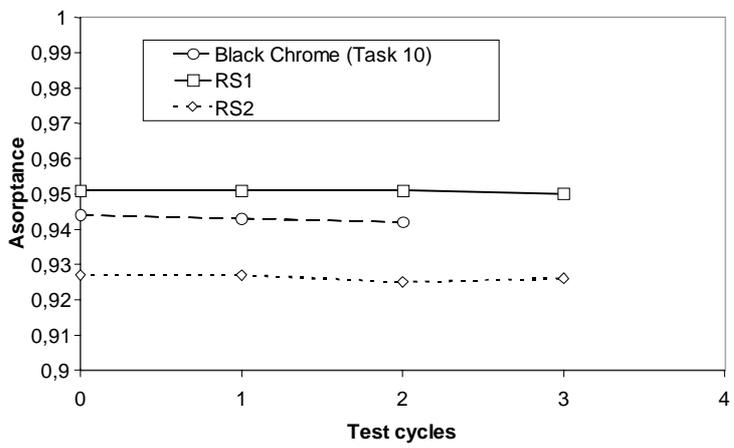
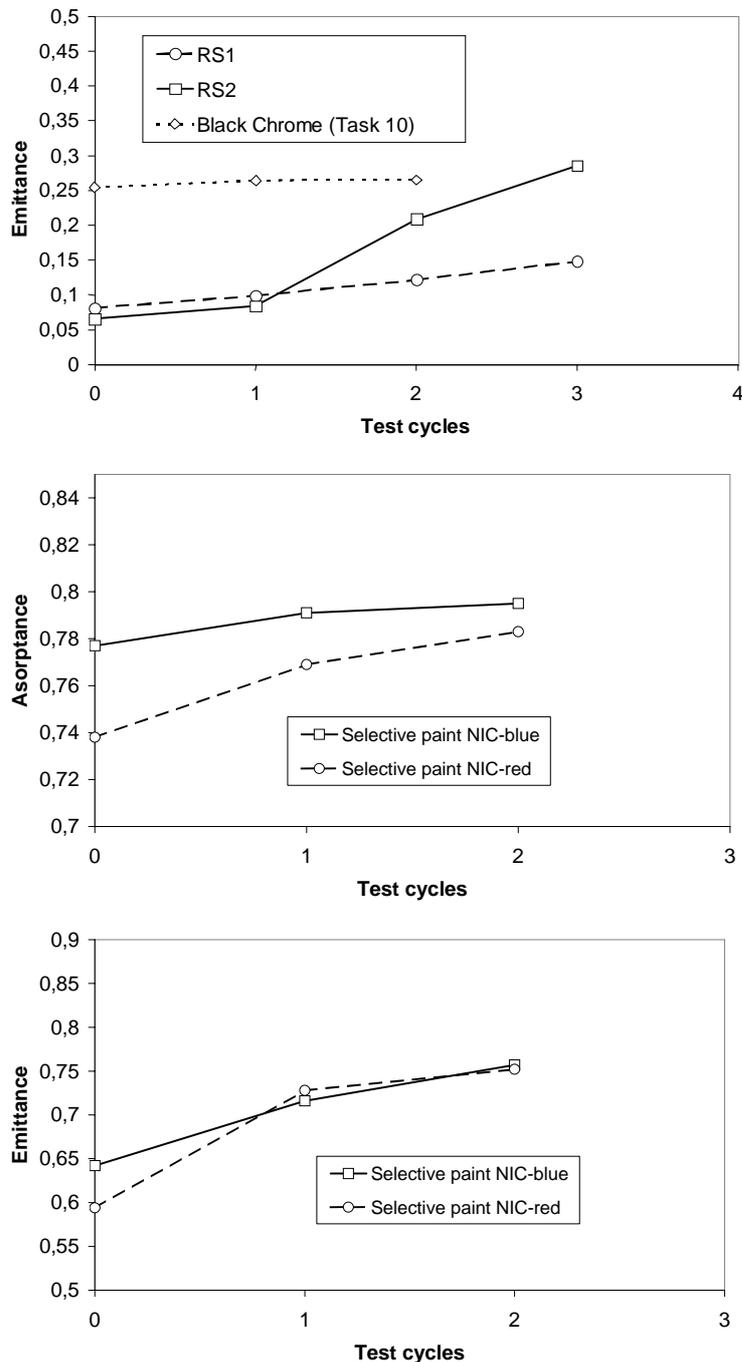
Fig. 1: Solar absorptance and thermal emittance of the absorber materials after corrosion testing according to corrosion test cycle II.

The test results obtained with the corrosion test cycles II are shown in Figures 1. In Figure 2 the test results with the corrosion test cycle I are shown. Failure times in corrosion test cycle I for the absorber materials, i.e. when the performance requirement $PC < -\Delta\alpha + 0.25 \cdot \Delta\varepsilon < 0.05$ is no longer met, were also assessed. The results are shown in Table 1. In Table 2 the metallic mass losses of the copper and zinc reference specimens determined after four cycles of testing according to the two corrosion test cycles are given.

As can be seen in Figure 1, it is only the red and green coloured Sunselect absorber materials that exhibit significant degradation in optical performance upon corrosion testing according to corrosion test cycle II after two weeks. It is mainly the emittance of coatings that is affected. On those samples degradation due to corrosion of the underlying metal substrate can be observed.

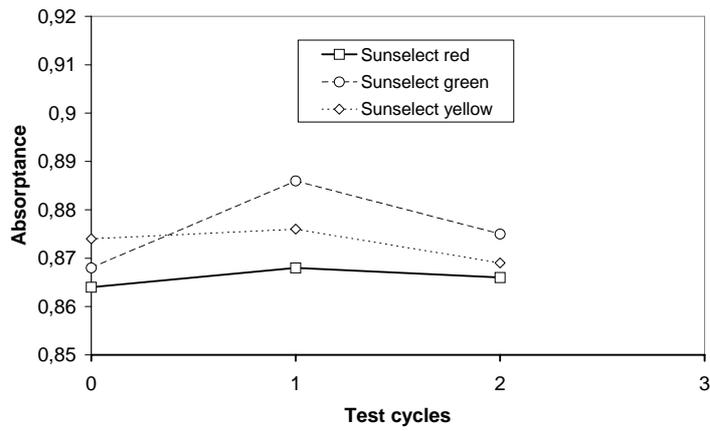
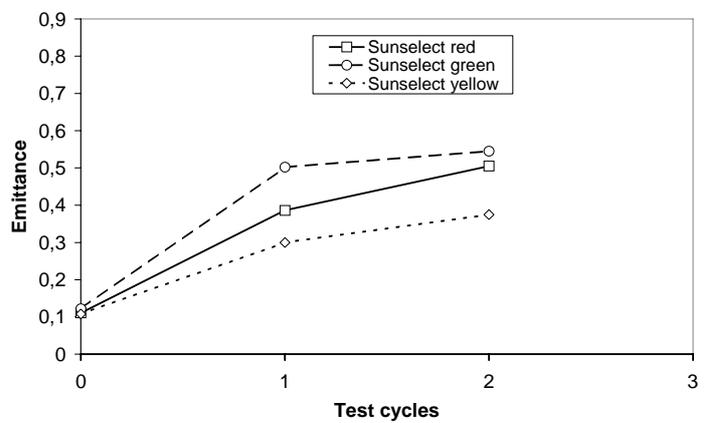
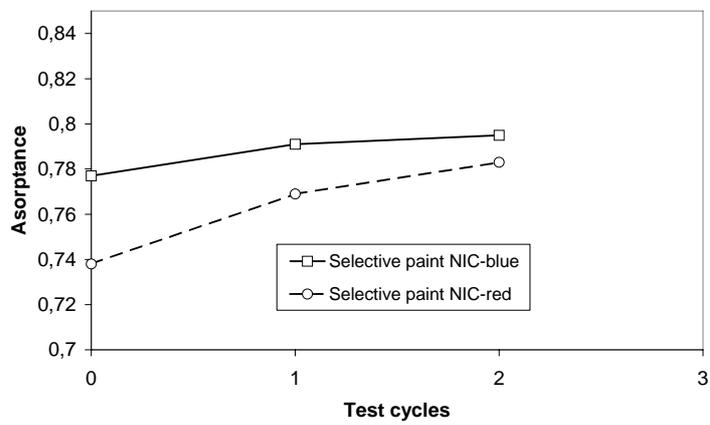
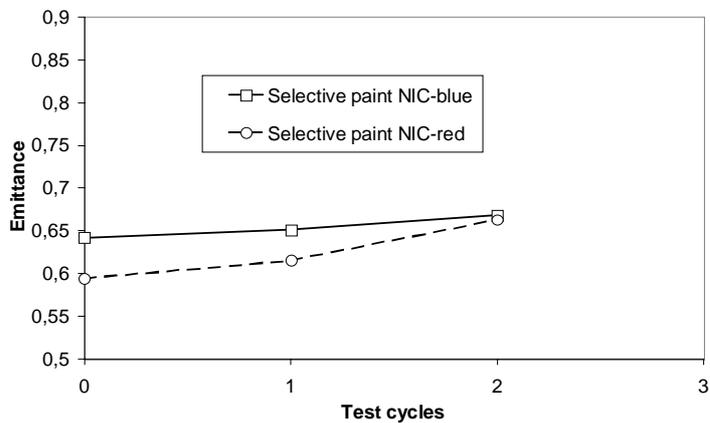
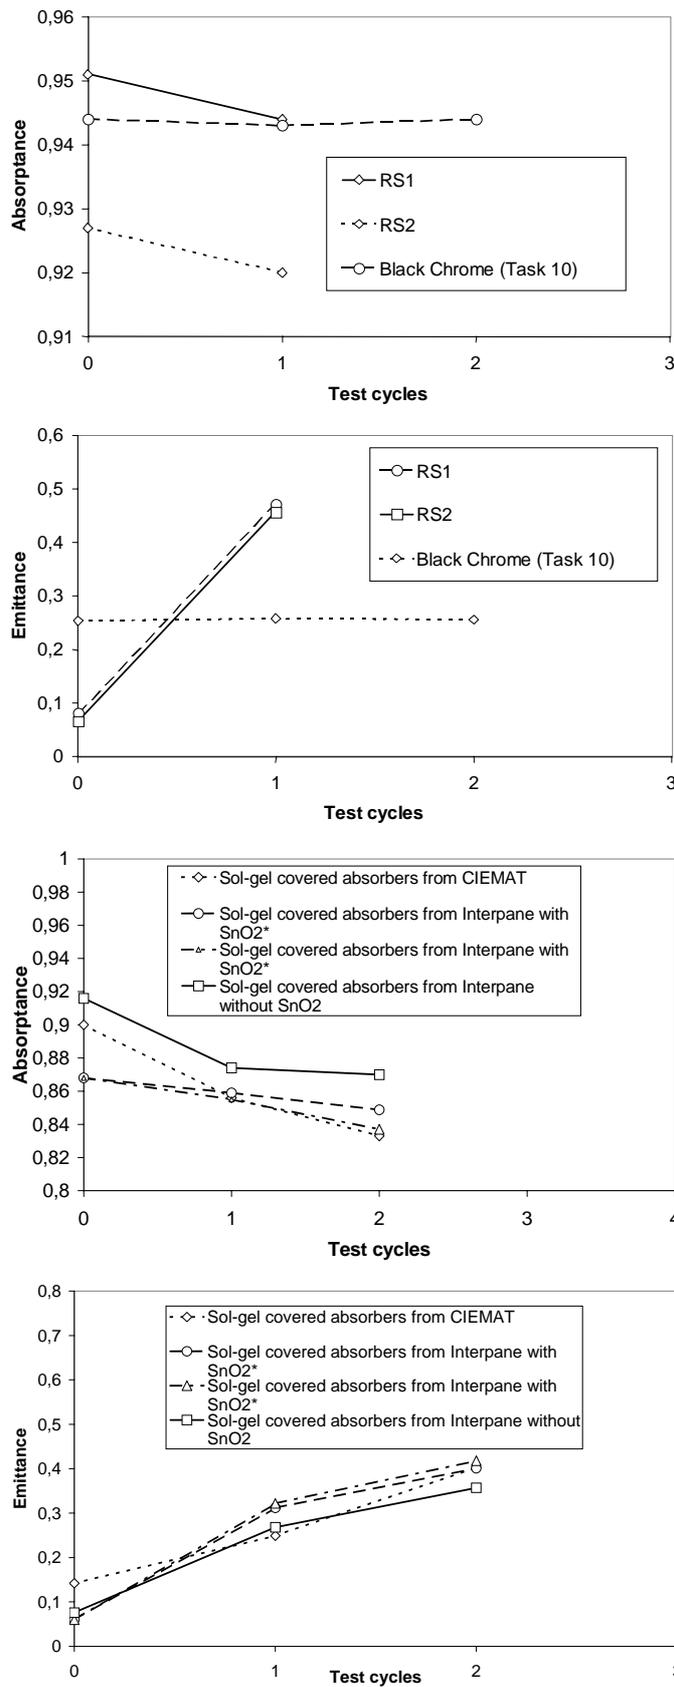
Fig. 2: Solar absorbance and thermal emittance of the absorber materials after corrosion testing according to corrosion test cycle I.

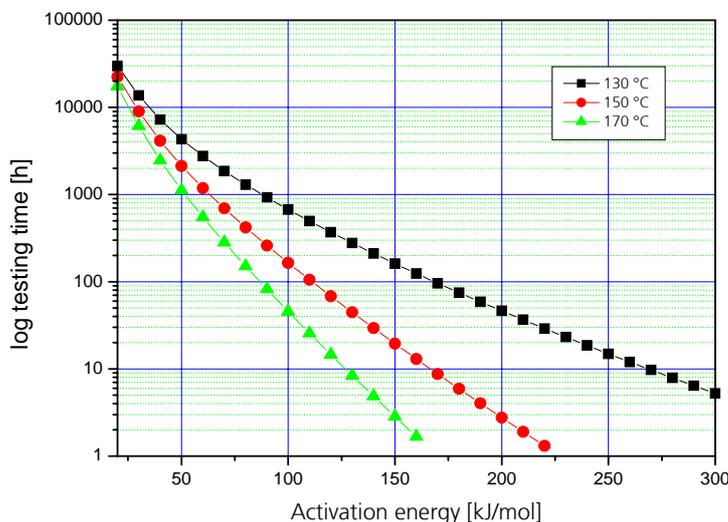
Fig. 3: Testing times for high temperature test.

Test conditions for temperature testing were derived from transformation of one-year data from outdoor monitoring results from the south 45° installed Black Chrome samples which were assumed to be the worst case for temperature load.

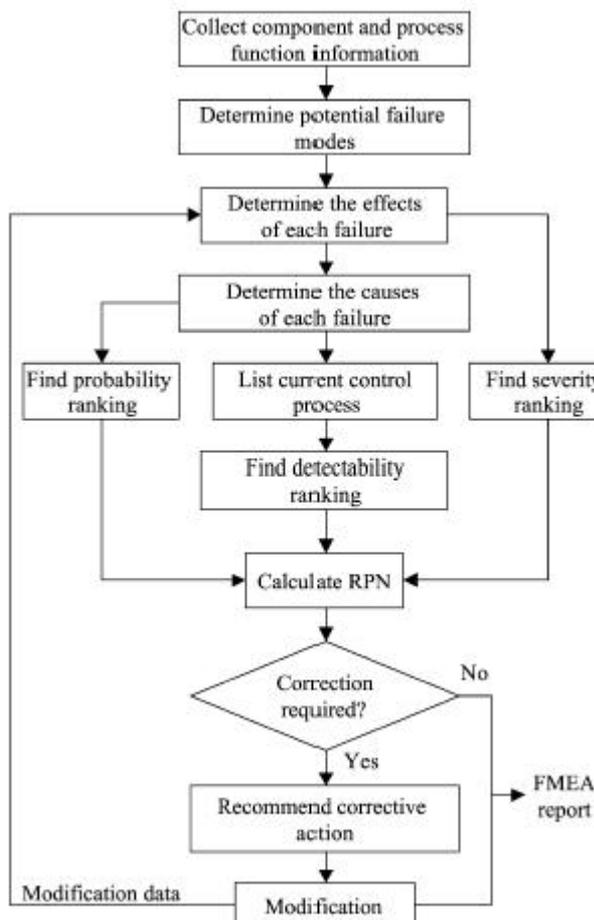
Fig. 1: FMEA process (Pillay, 2003)

The FMEA procedure can be divided into several steps as shown in Fig. 1.
