TASK 27

Performance of Solar Facade Components

Final Report

PROJECT B3: Durability and reliability assessment of static solar materials

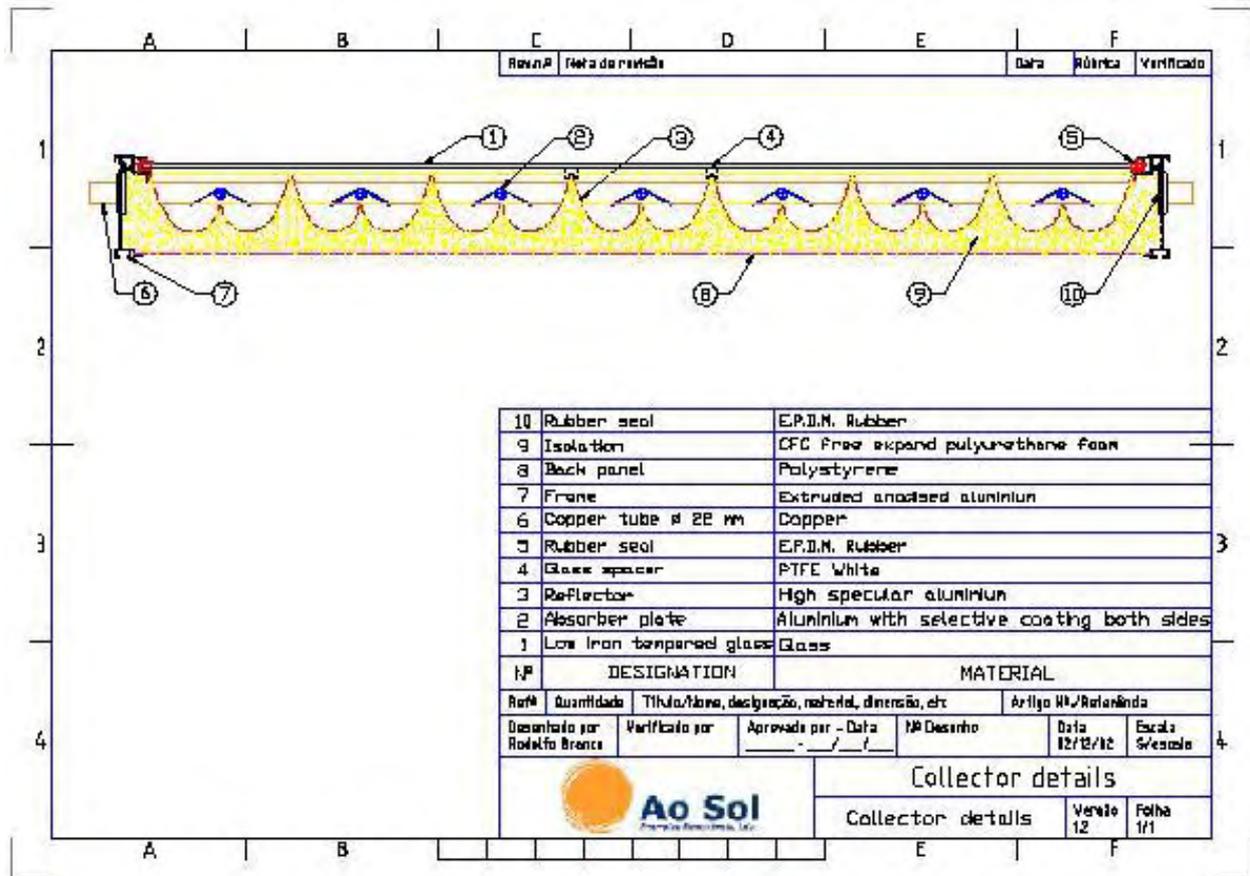
Figure 2: CPC Solar collector cross-section

Before identifying the product functions, we must start by the structural analysis, identifying each part of the collector and corresponding material used in each of the parts. In our case, this identification is shown in Fig. 2, which can be considered equivalent to a structural diagram too.

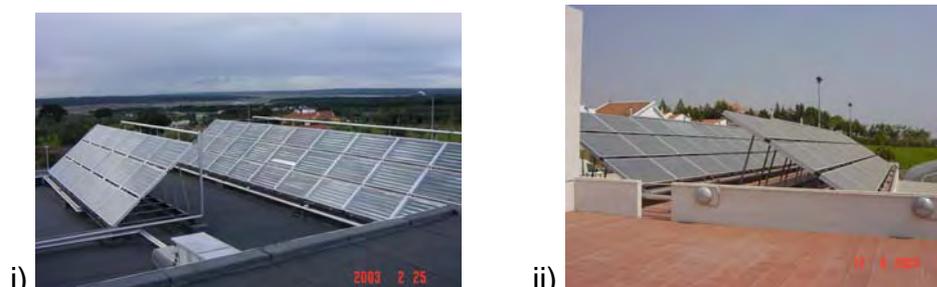
Fig.5 Public swimming pools of i) Alcácer do Sal and ii) Torrão

The main problems encountered in the reported visual inspection of 23 solar installations result from bad design of the solar system or bad installation of the system. This is quite evident from two similar system installed in the same county of Alcácer do Sal to heat water of swimming pools. Both systems have i) 120 m² of CPC collectors of the same manufacturer, ii) a solar system working with a furnace burning biomass. But, as we can see from the pictures below, one doesn't present any evidence of degradation (Torrão) and the other one presents.

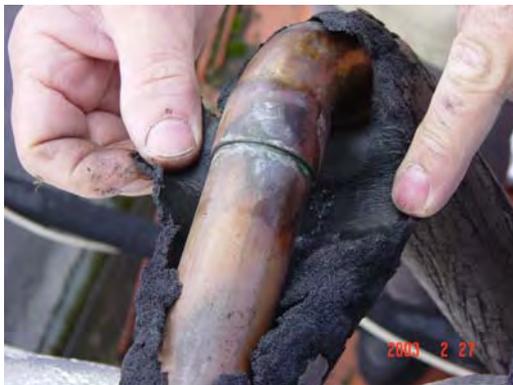
c) Inexistent mechanical protection for insulation

It results from bad design and/or of bad installation. It can be avoided by a procedure similar to that of proposed in a).

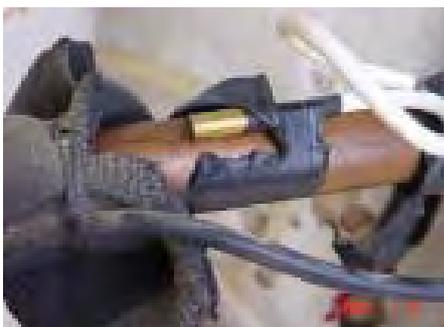
d) Permanent liaison of primary circuit to network

It results from bad design and/or from bad installation. It can be avoided by a procedure similar to that of proposed in a).

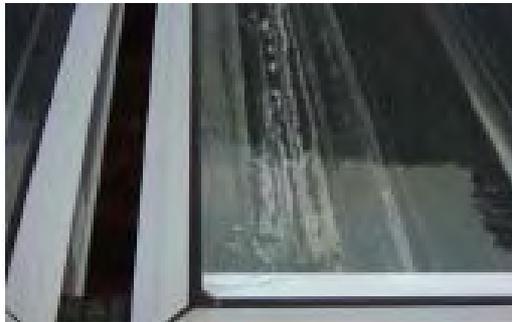
By comparison of Tables 2, 3 and 4 we can conclude that the actual set of qualification tests doesn't include an appropriated test to evaluate the behaviour of the ventilation system of the collector box.

It can be avoided by a procedure similar to that of proposed in a).

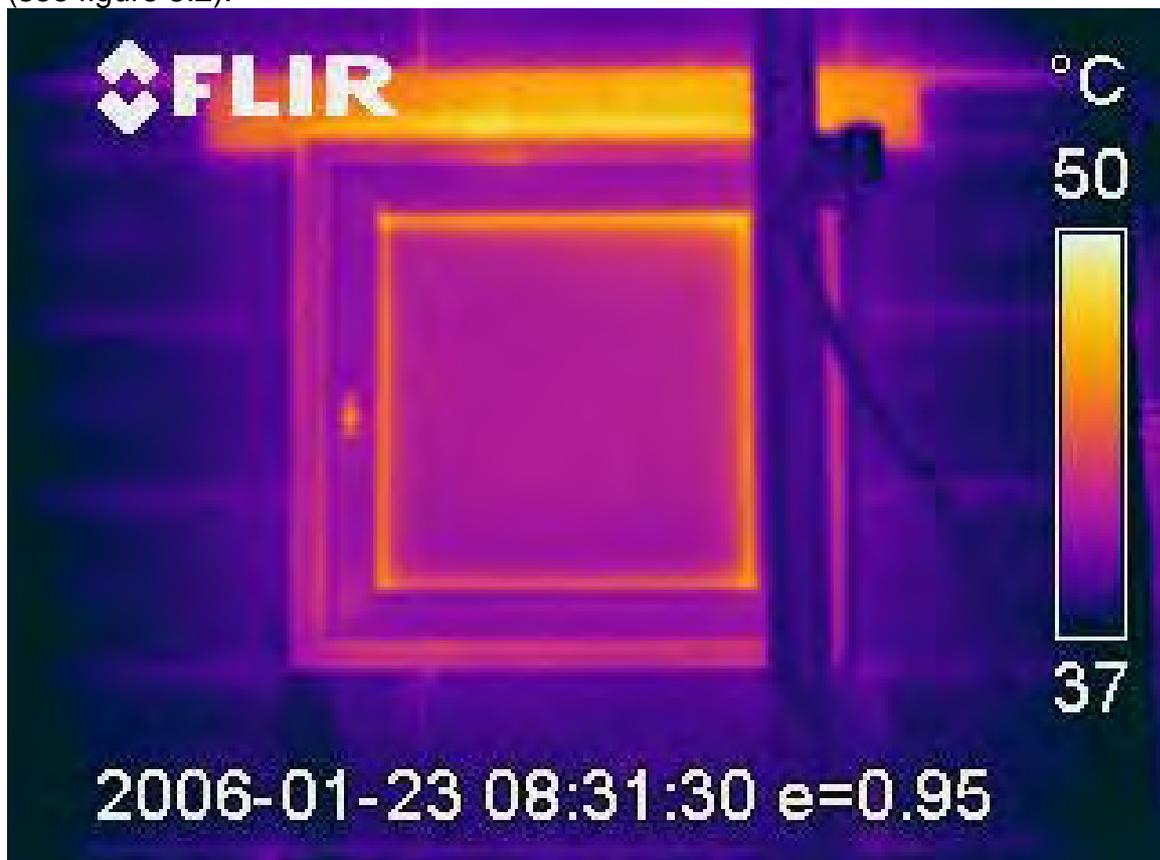
Figure 5.1: Temperature distribution at the window/wall interface. The bar at the right side of the window belongs to the scanner of the humidity sensor.

The temperature was measured with an Infrared camera (see figure 5.1). An optical sensor was applied for the humidity measurements. The working principle is to measure the reflected light at the water-absorption band at $1.4 \mu\text{m}$. The incident light and the measured light are transferred by a wave-guide to the supply and detection electronics (see figure 5.2).

Four leaks became visible after some time. The 3 smaller leaks at the low part came from water droplets which penetrated through the frame sealant and were sucked by the wall (see figure 5.7). The leakage at the top-side resulted from a ventilation opening. This opening can be identified in the infrared picture (figure 5.1) as well.

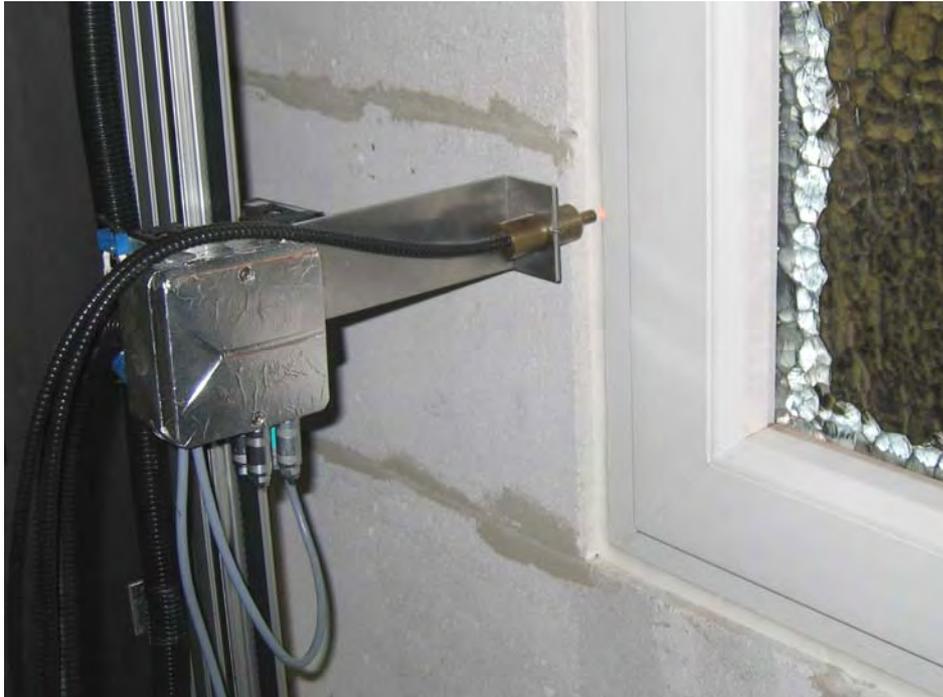
Figure 5.2: The humidity sensor mounted on the scanner

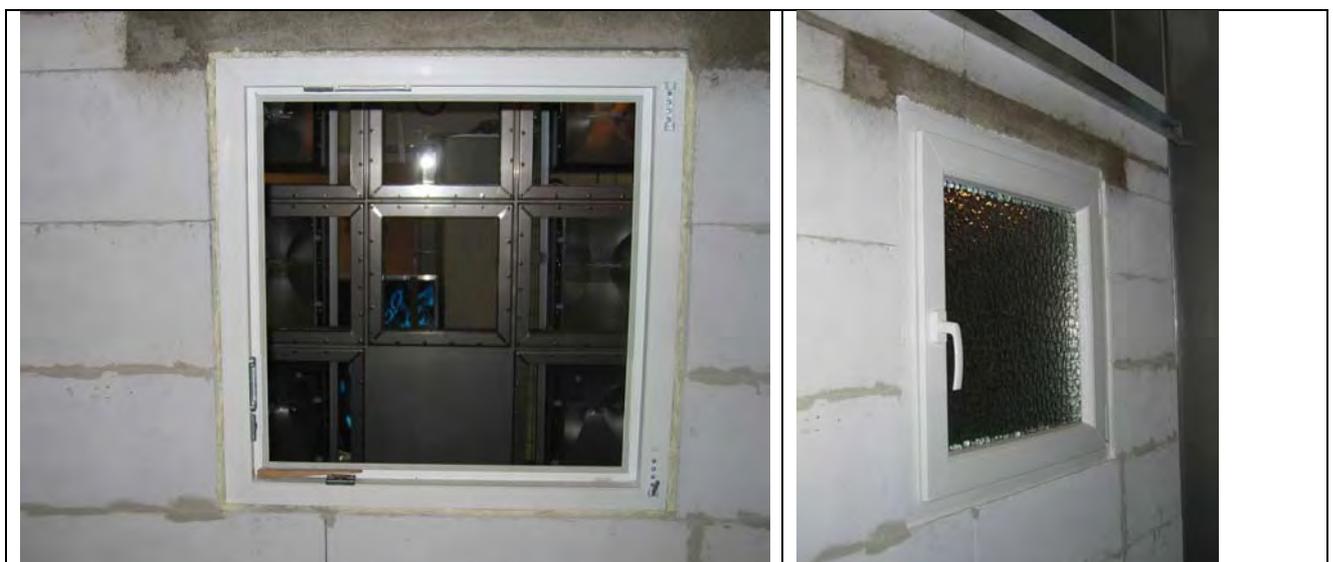
Figure 5.3: Window in the wall to be tested

A commercially available window was mounted in a wall (Dimension 165cm x 215cm x 15cm), as shown in figure 5.3, which was placed between the two parts of the double climatic chamber of the ISE (see figure 5.4).

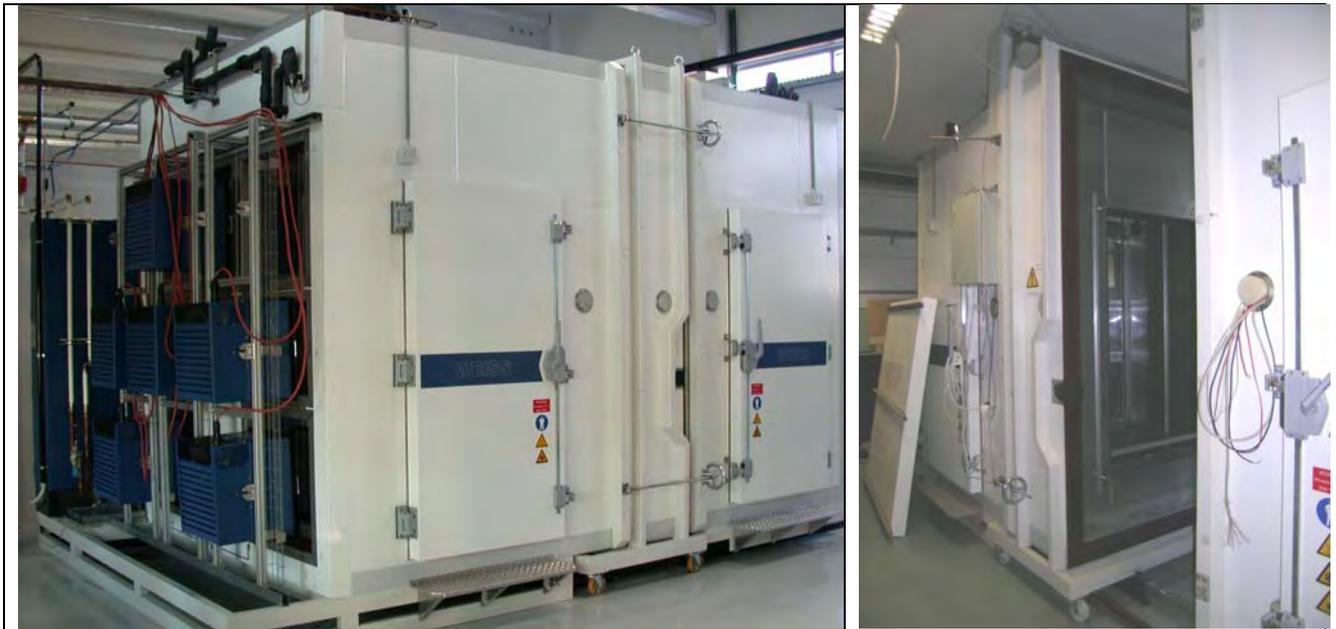
Figure 5.4: Climatic chamber and sample holder, which allows the installation of samples with dimensions of more than 1.8 m times 1.5 m.

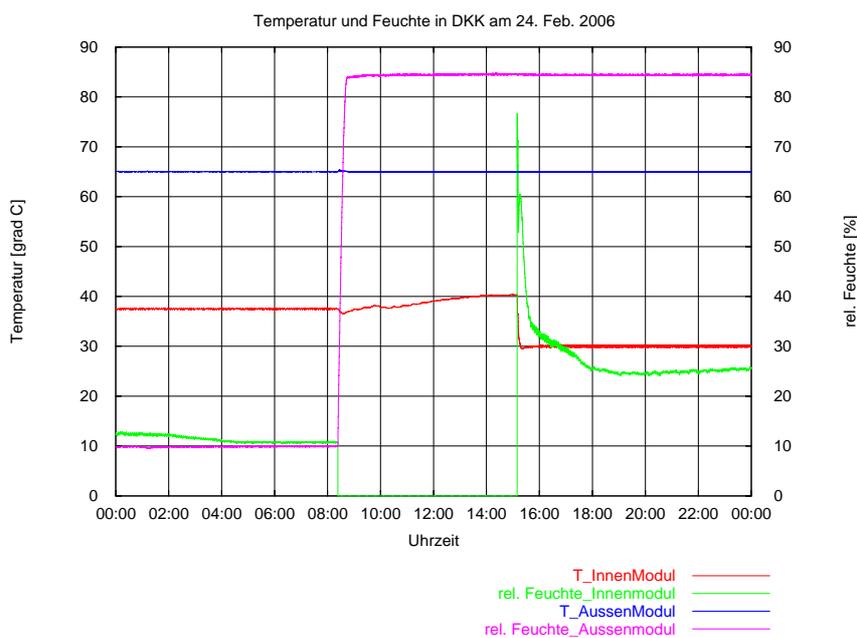
Figure 5.5: Temperature (inside in red, outside in blue) and relative humidity in the two chambers.

After waiting for drying out of the wall the outside of the wall was exposed to 95% relative humidity at 60°C. The other side was not conditioned. The monitoring of the climatic conditions is shown in figure 5.5.

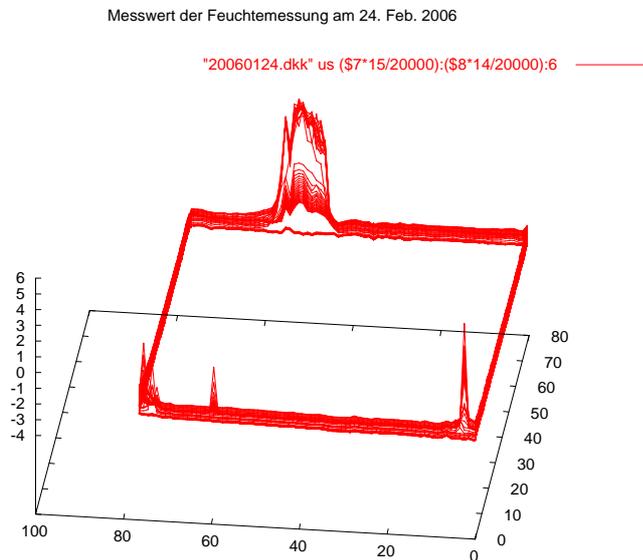
Figure 5.6: Signal of the humidity sensor by scanning the window-wall interface frequently. The upper lines come from the top part.

The measurements with scanner and IR camera are shown in figure 5.6 and 5.1.

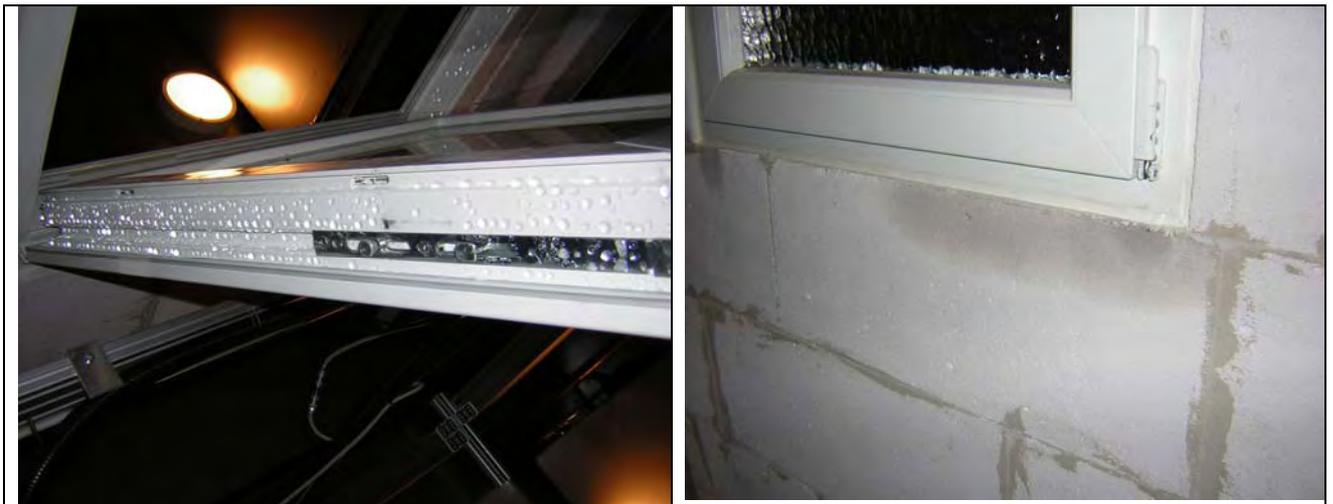
Figure 5.7: Condensation in the window frame and wetting of the wall at the bottom side.

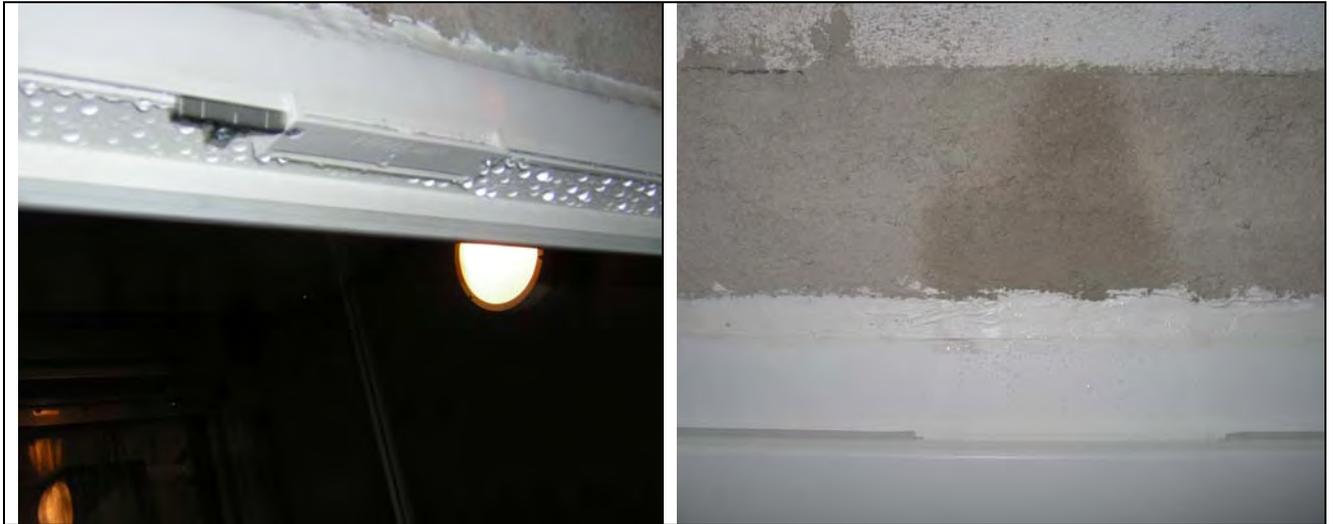
Figure 5.8: Condensation in the window frame, ventilation opening and wetting of the wall at the top side.
