Subtask D: Case Studies Highlights and results

6th Industry Workshop of IEA SHC Task 50:
Advanced Lighting Solutions for Retrofitting Buildings

Advanced Lighting Solutions for Retrofitting Buildings

Evaluation of daylighting and electric lighting renovation for a landscape office

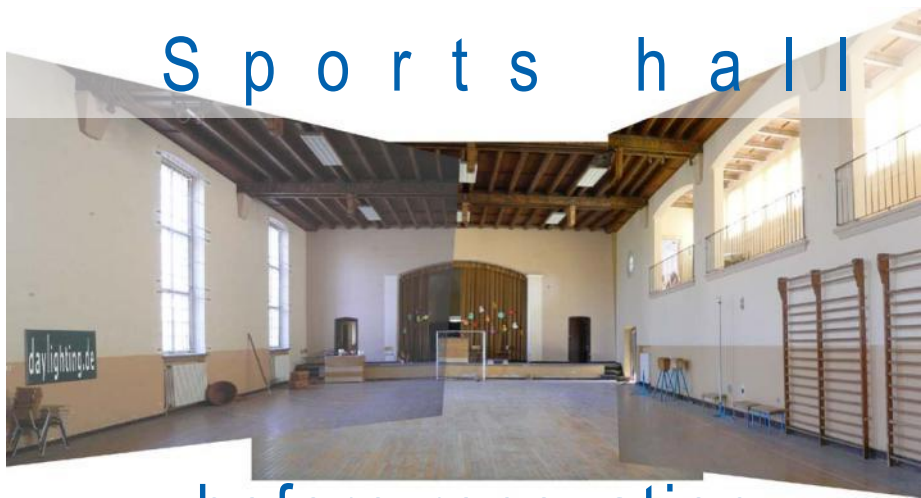
Sports hall in a school

before renovation

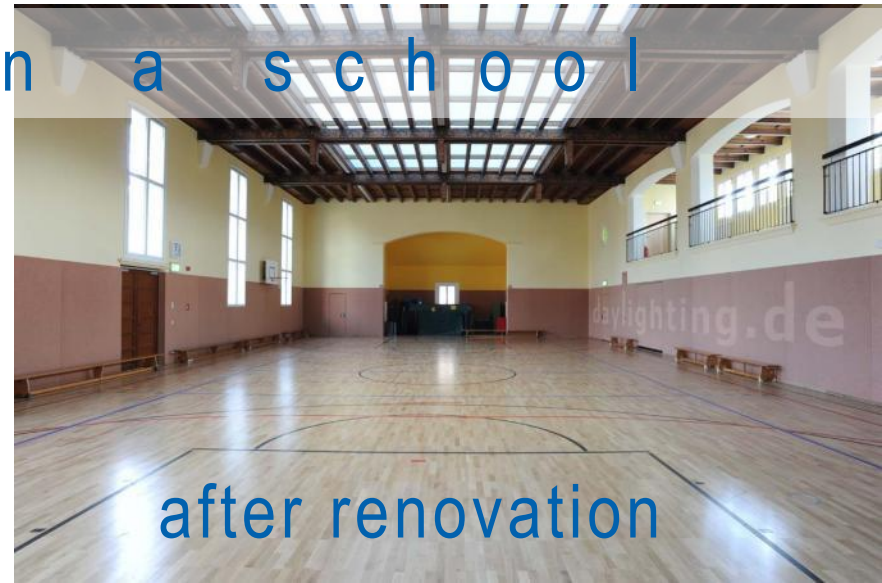
after renovation

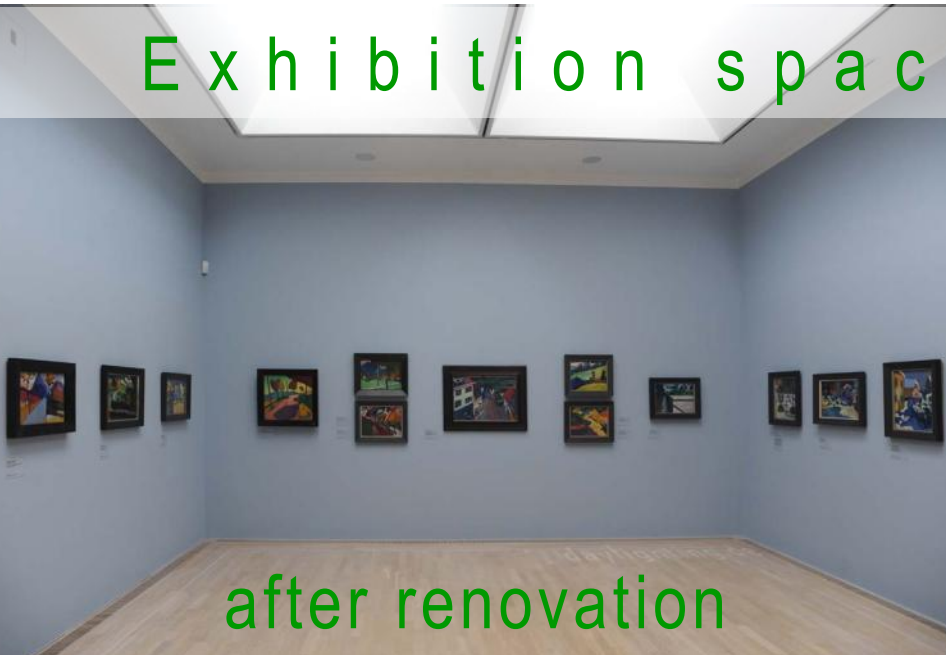
Exhibition space in a museum

after renovation

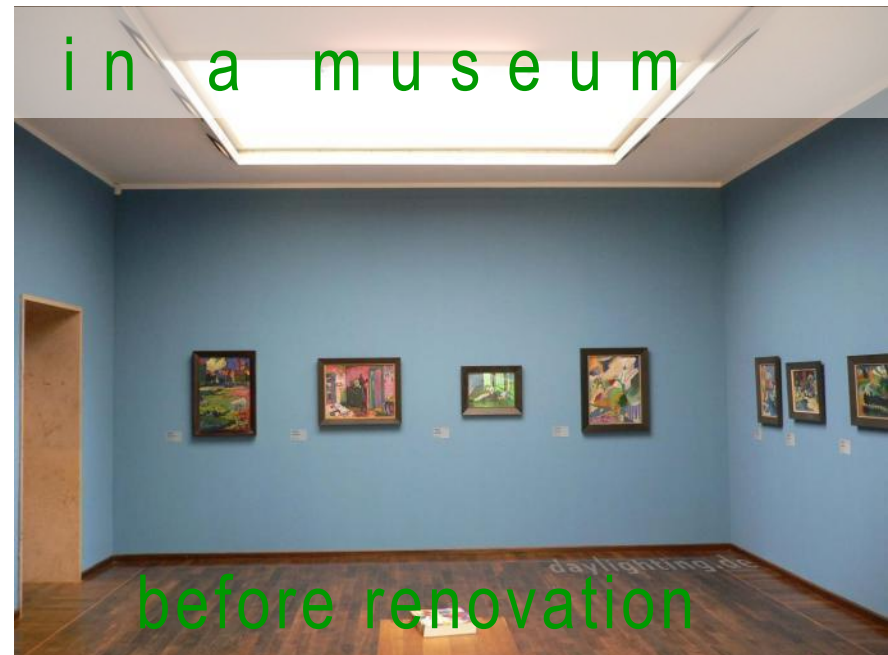
before renovation

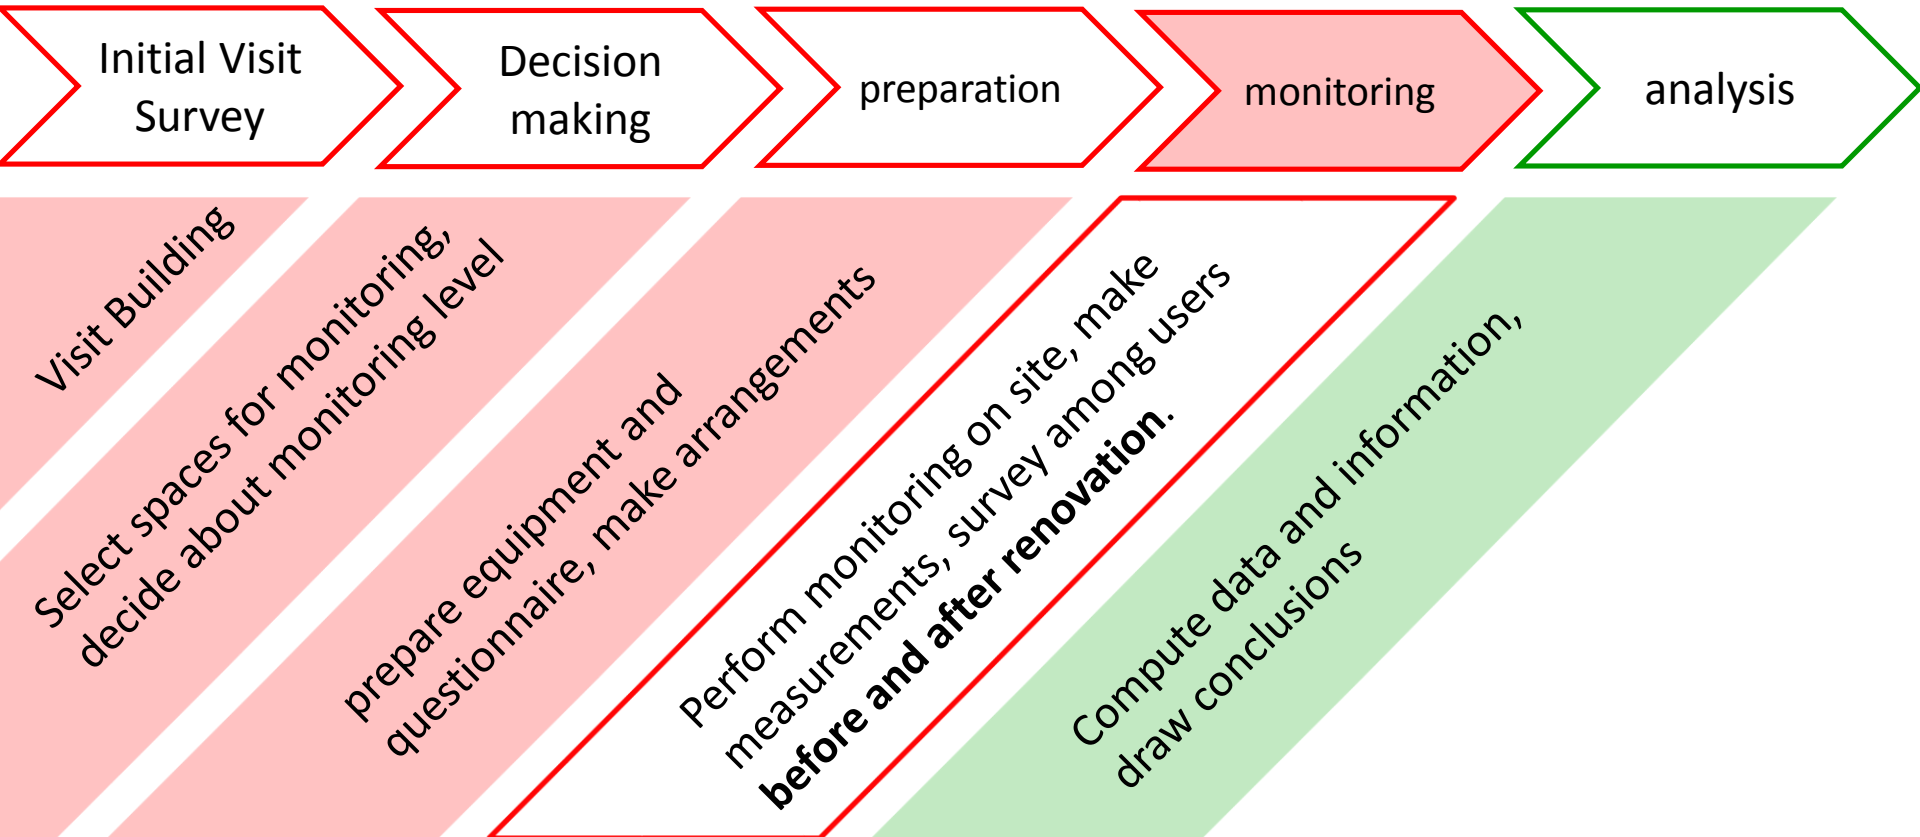
THE PROTOCOL STRUCTURE

5-steps procedure

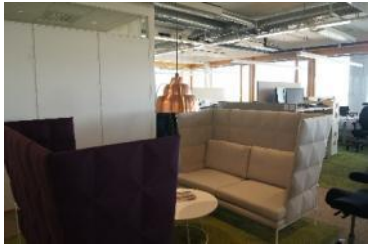
Less “obstacles”, more daylight

Different workplaces arrangement and cellular meeting rooms removed

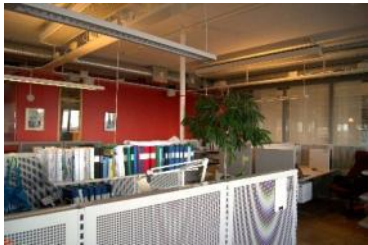
Improved surfaces reflectance

Back wall from dark red to white improved daylighting

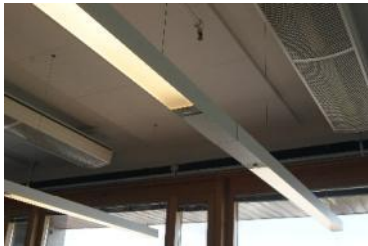
Better T5 fluorescent optics

Better light distribution over the work place

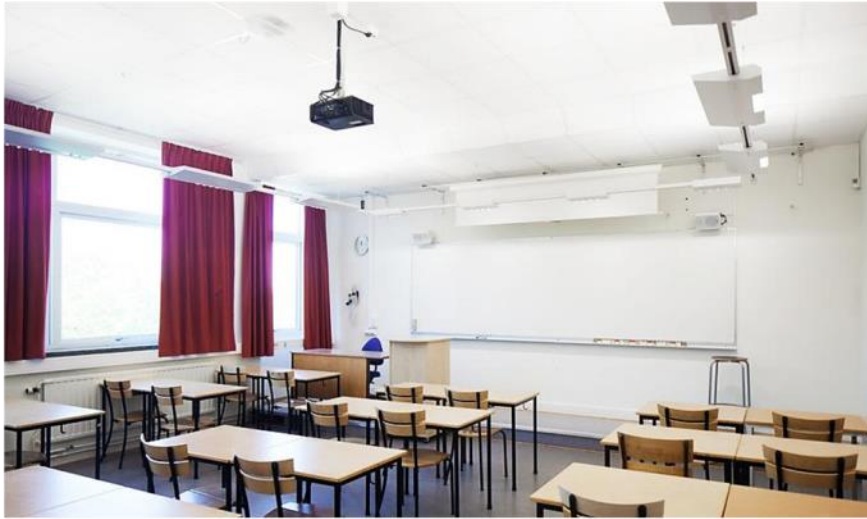
**100% indirect
LED (4000 K)**

Evaluation of students appreciation and energy saving of direct T5 Vs indirect LED lighting

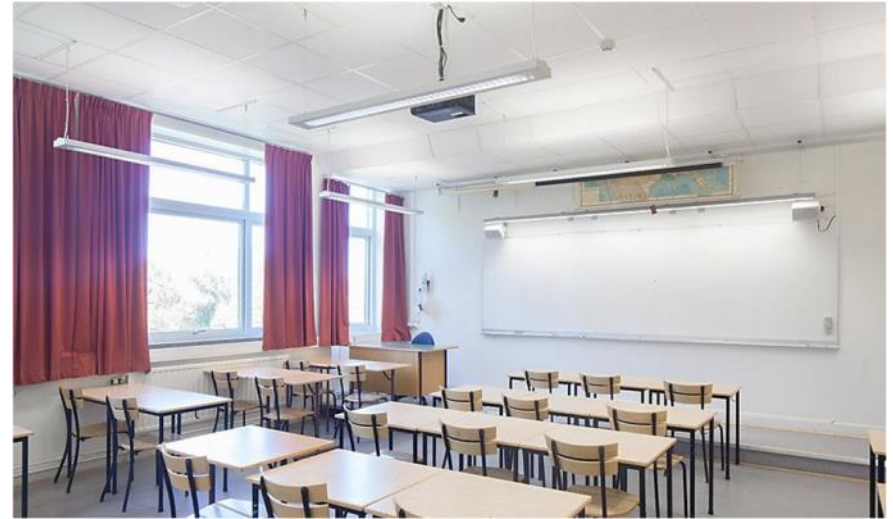
**50/50% direct/indirect
FLUORESCENT T5 (4000 K)**

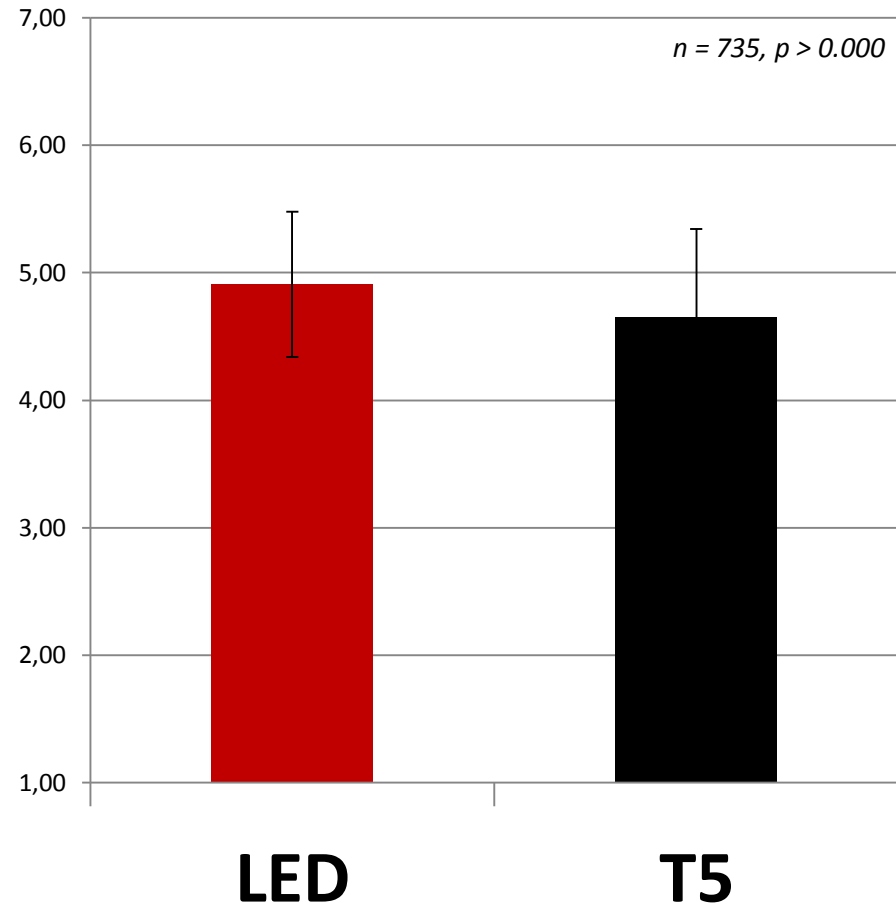
Perceived quantity of light

**Very little saving (about 1%),
BUT...**

the space is perceived brighter
despite the same horizontal
illuminance

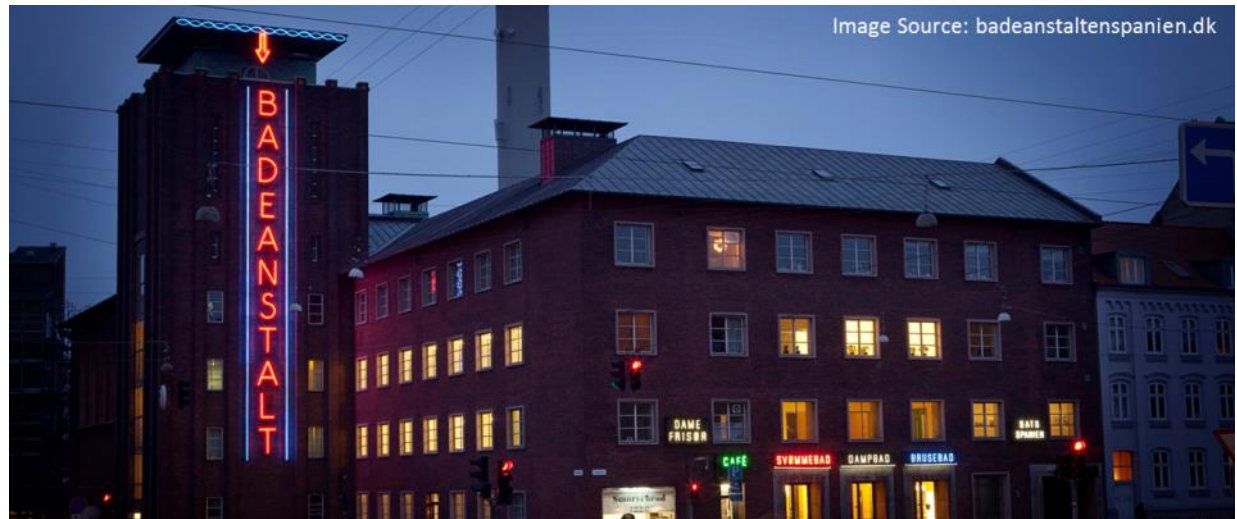
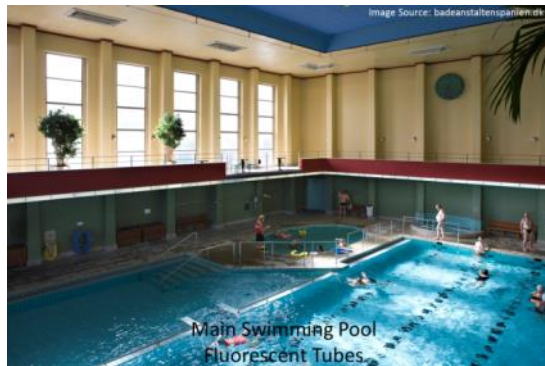
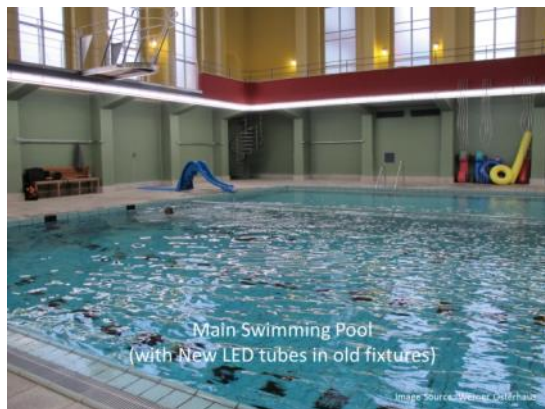
Public Indoor Pool “Spanien”, Aarhus, DK

Evaluation of electric lighting retrofit from T8 fluorescent tubes to LED tubes in swimming pool area and new fluorescent lamps in other areas

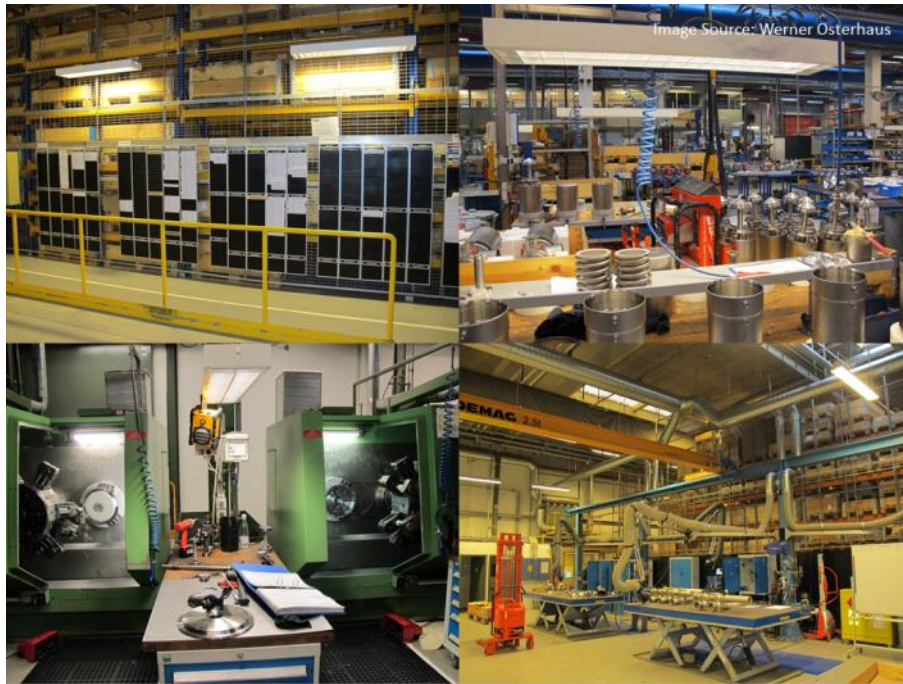
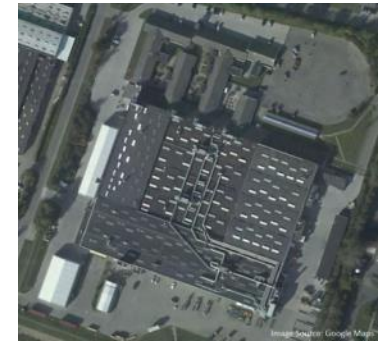
Factory Building, Kolding, DK

Evaluation of existing electric lighting and a partial retrofit in some critical manufacturing areas

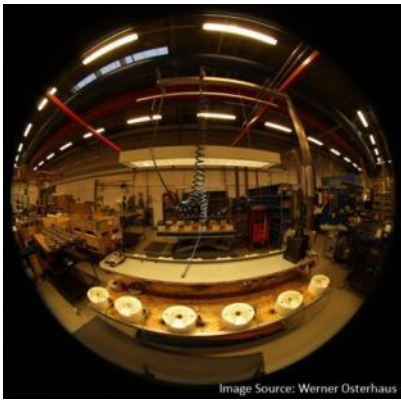
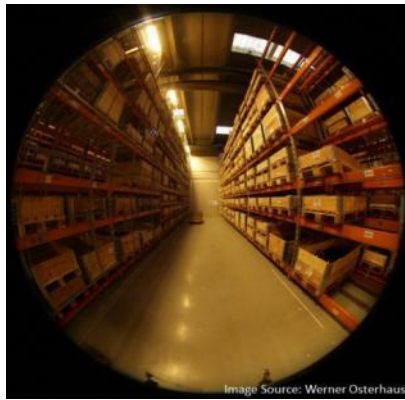
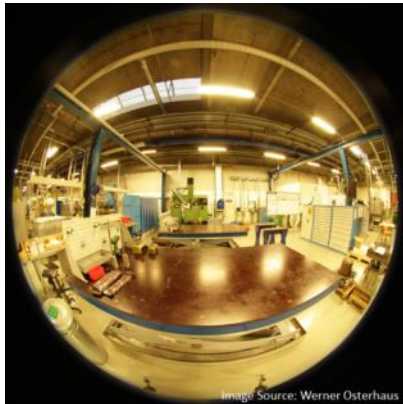
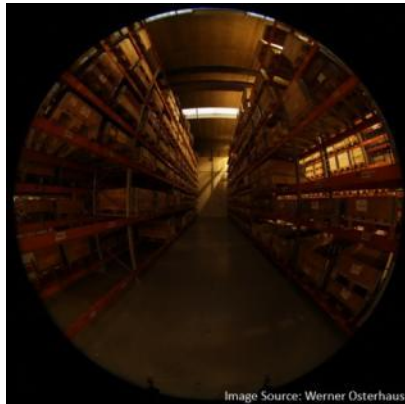
Factory Building, Kolding, DK

- In general, very low daylight levels due to significant obstruction of skylights through ventilation ducts, cable trays and/or storage shelves
- Electric lighting already upgraded at key factory workstations
- Disability and discomfort glare experienced at some workstations
- Electric lighting levels in aisles between storage shelves far too low
- Luminaire mounting position and/or direction not changed when shelving units were re-configured
- Proposals developed to improve lighting and thus safety in storage aisles and other critical areas

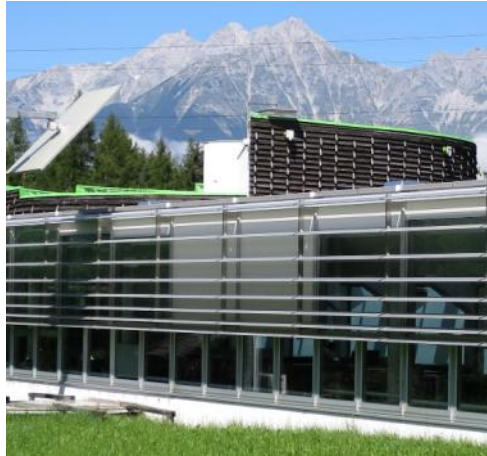
Bartenbach R&D Office, Aldrans, AT

Daylight solution: exterior louvers with varying distance between slats optimized for location, additional screen for luminance control

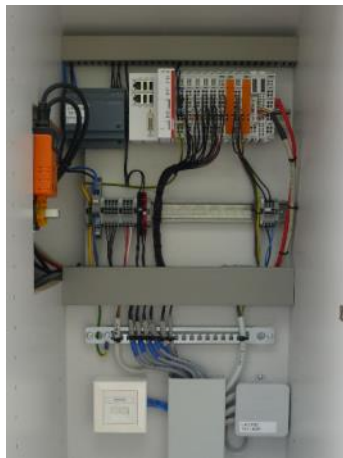
Control: sensors for occupancy, workplan and exterior illuminance, wind speed, temperature

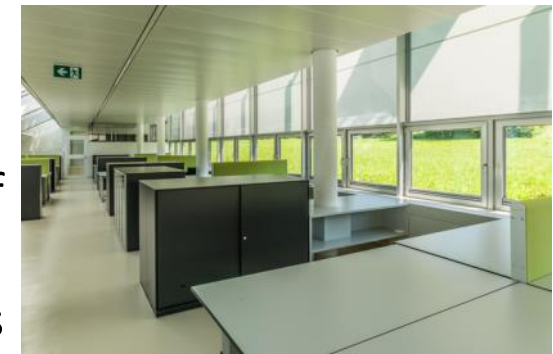
Interior design: redesign of interior surfaces, acoustical ceiling, acoustical panels

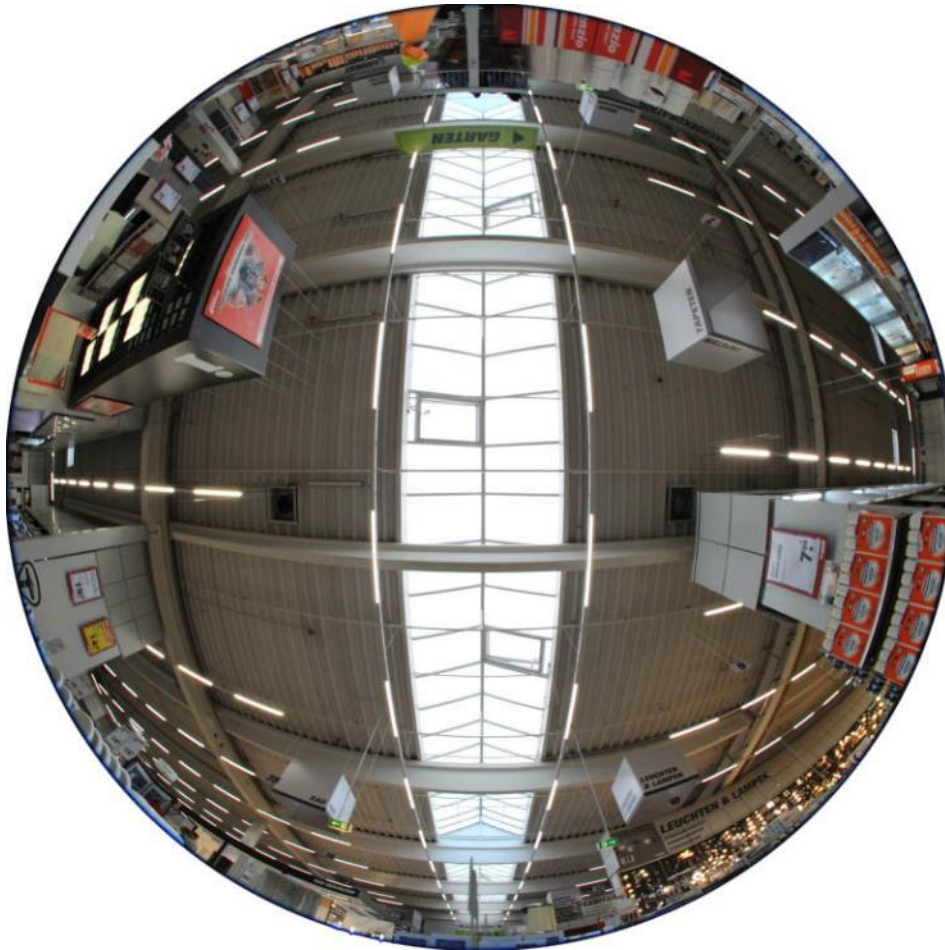
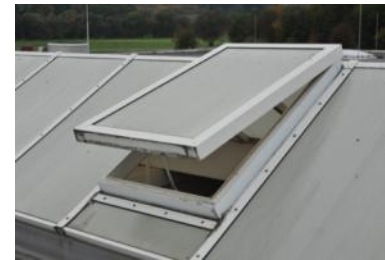
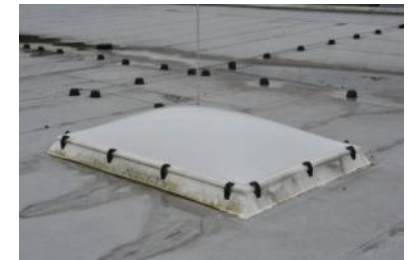
DIY-Market, Coburg, DE

Evaluation of lighting retrofit in DIY-Market

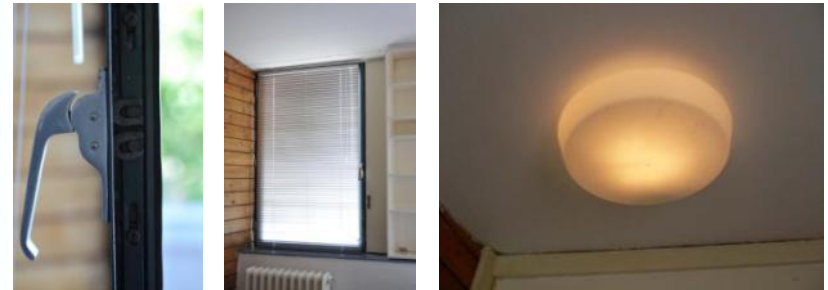
Student-Village-Schlachtensee, Berlin, DE

Evaluation of student-room in listed monument before and after the renovation

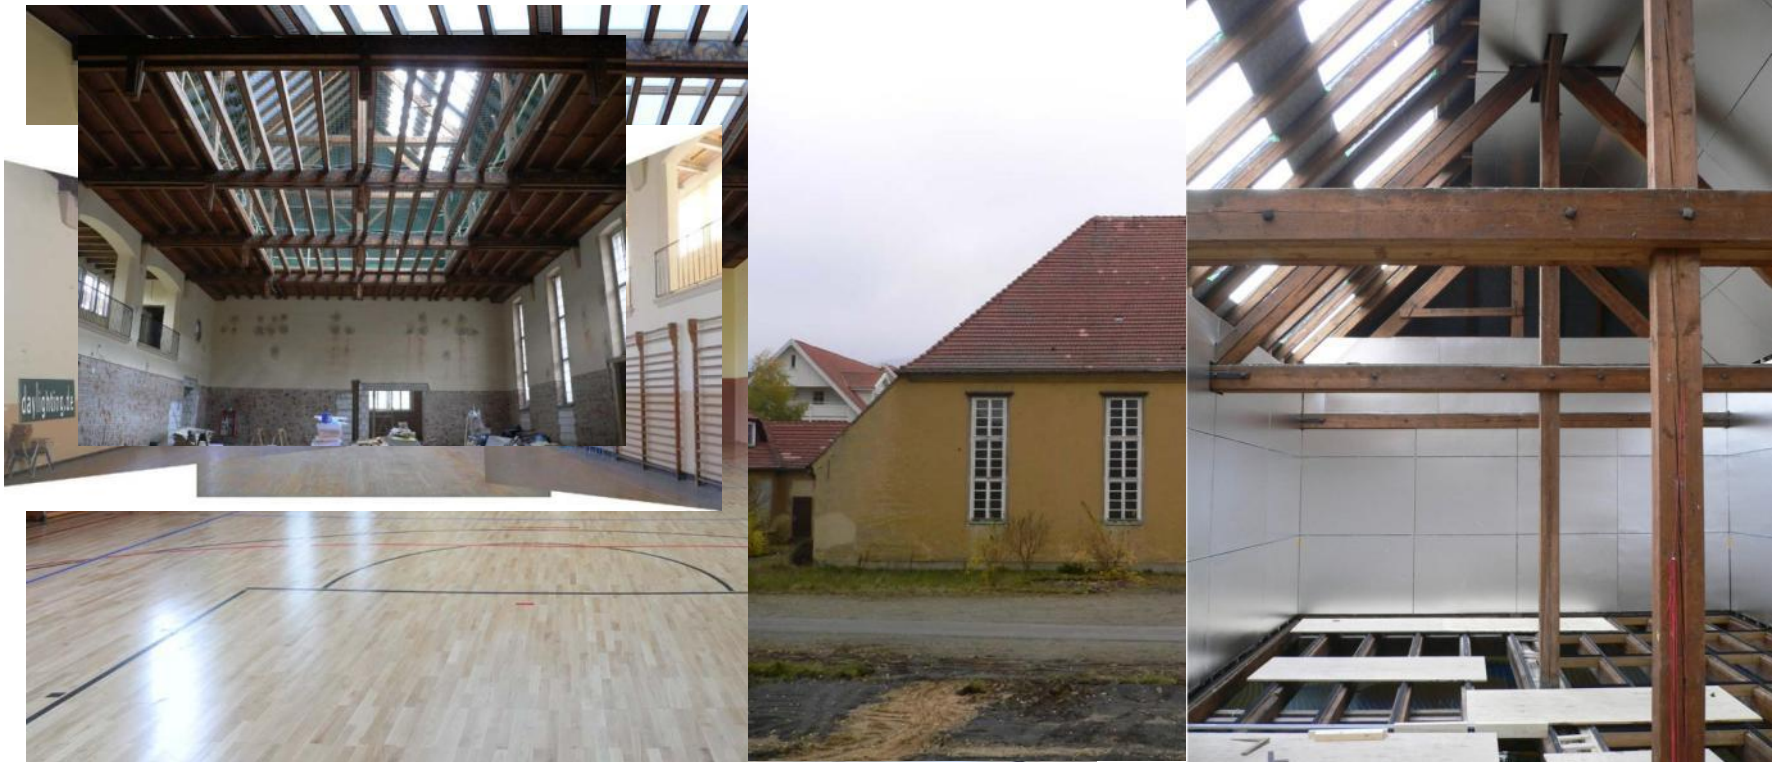
Fröbelschool, Olbersdorf, DE

Renovation of Façade and new rooflight to increase daylight level in sports-hall

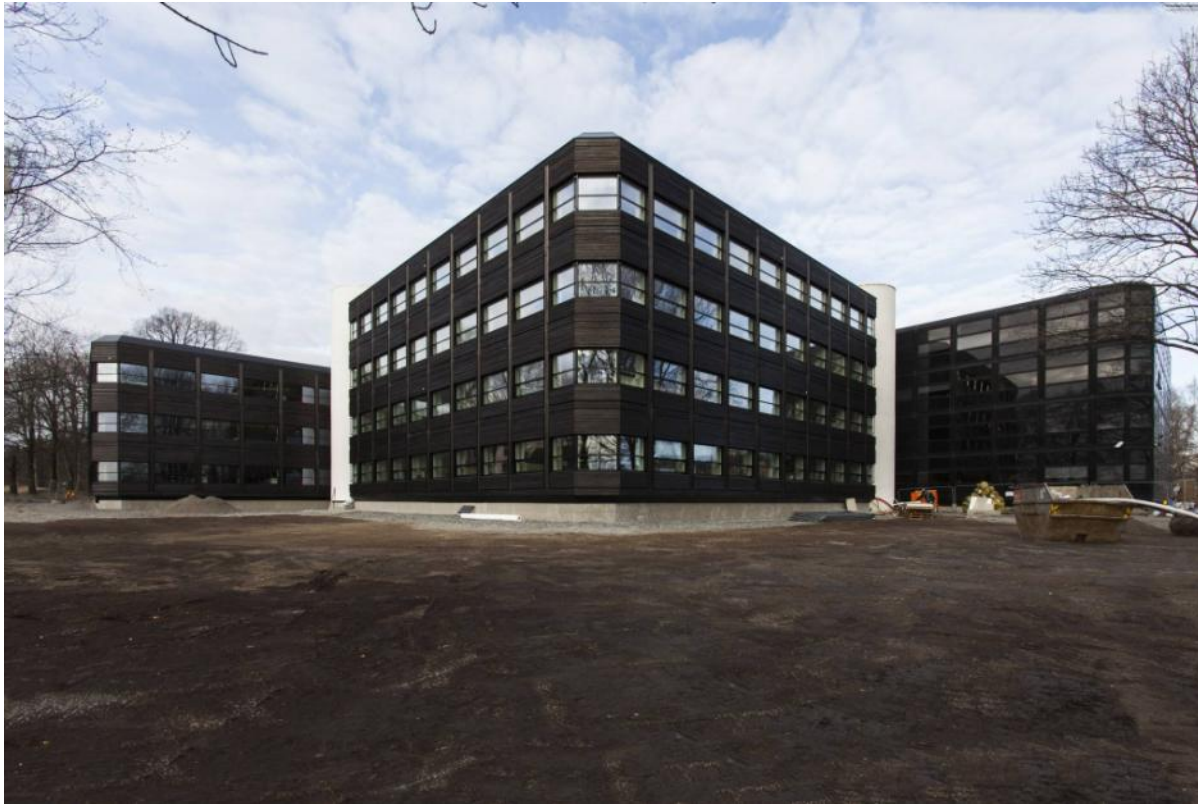
Powerhouse Kjørbo, Oslo, Norway

Complete renovation to achieve ZEB

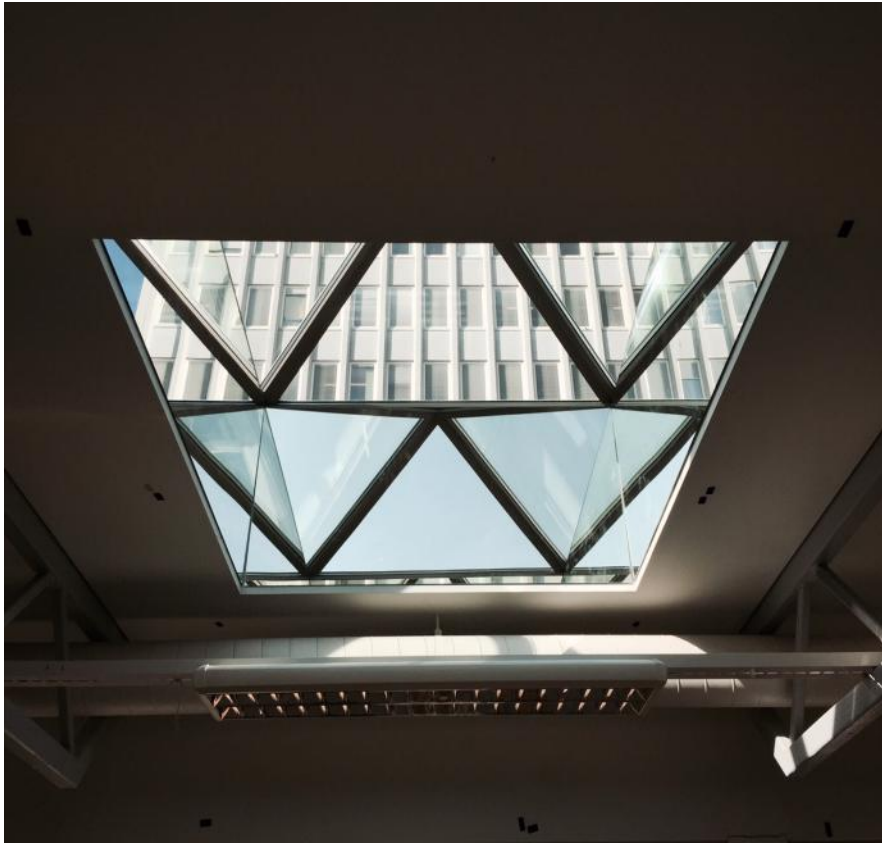
Campus studio, NTNU, Trondheim, NO

Retrofit of skylights+sunlight diffuser

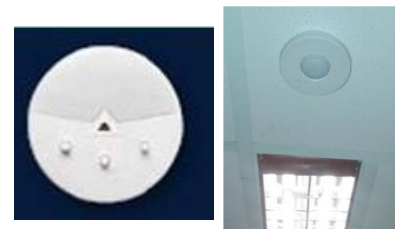
Pos retrofit

T5 fluorescent lamps (2 x 28) , electronic ballasts, daylighting and occupancy responsive sensors in rooms and corridors

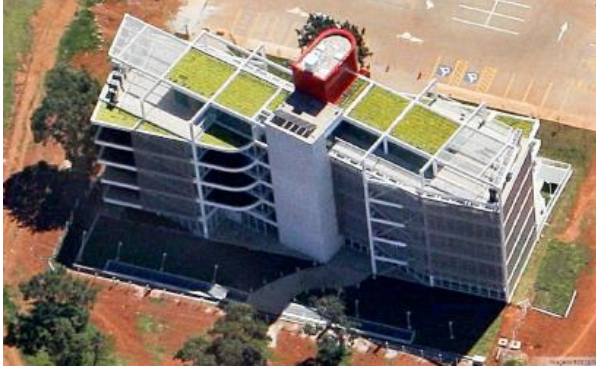
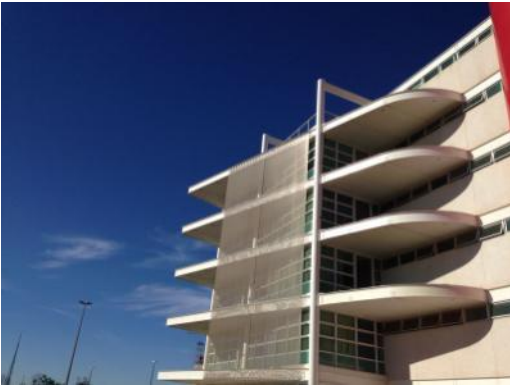
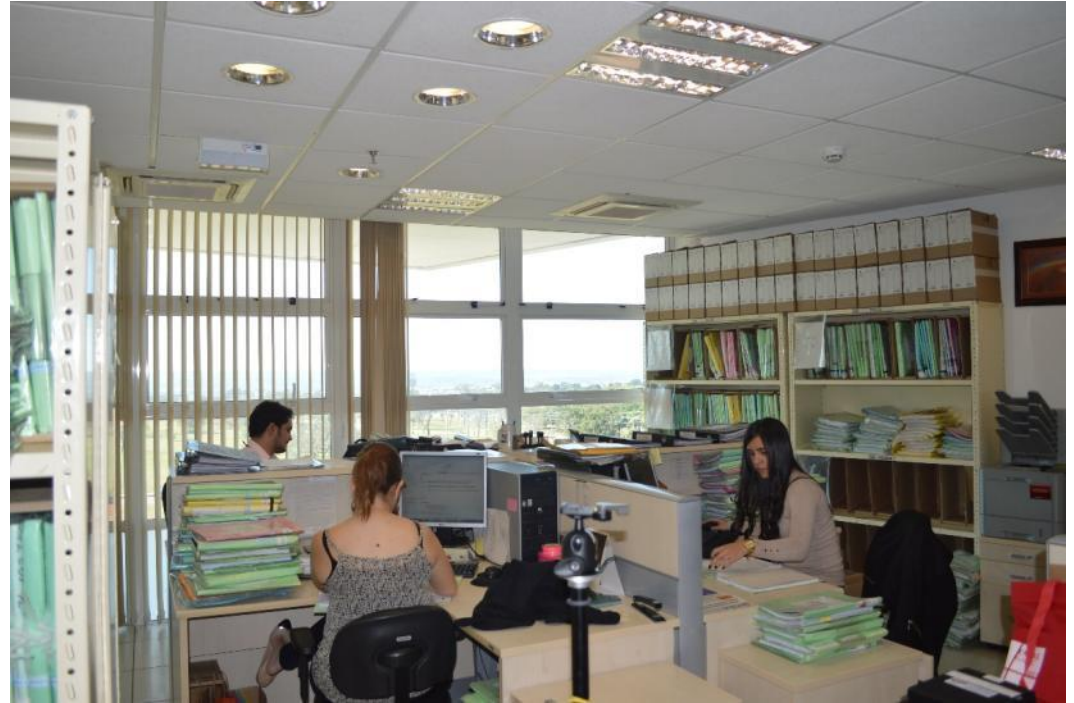
Forum of Environment and Public Finance TJDF-T, Brasília, BR

Evaluation of daylighting solutions and electric lighting and lighting control strategies in a new office public building

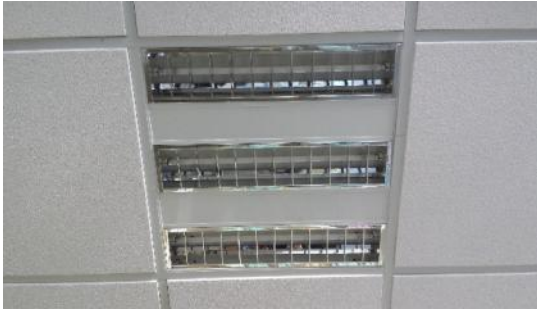
T5 fluorescent lamps (3 x 14 W), manual on/off, electronic ballast

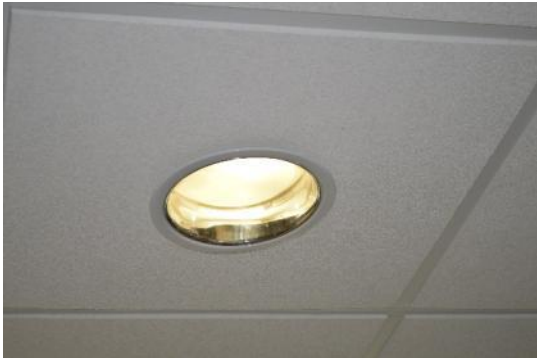
Compact fluorescent lamp (1 x 18 W), manual on/off, electronic ballast

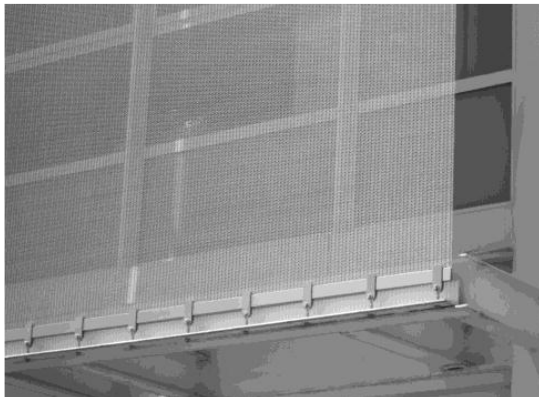
Solar protection on windows
